Denali Park Realignment (MP 344-348) Feasibility Study

FTA Grant AK-55-X003

ARRC Project No. 10437

Alaska Railroad Corporation

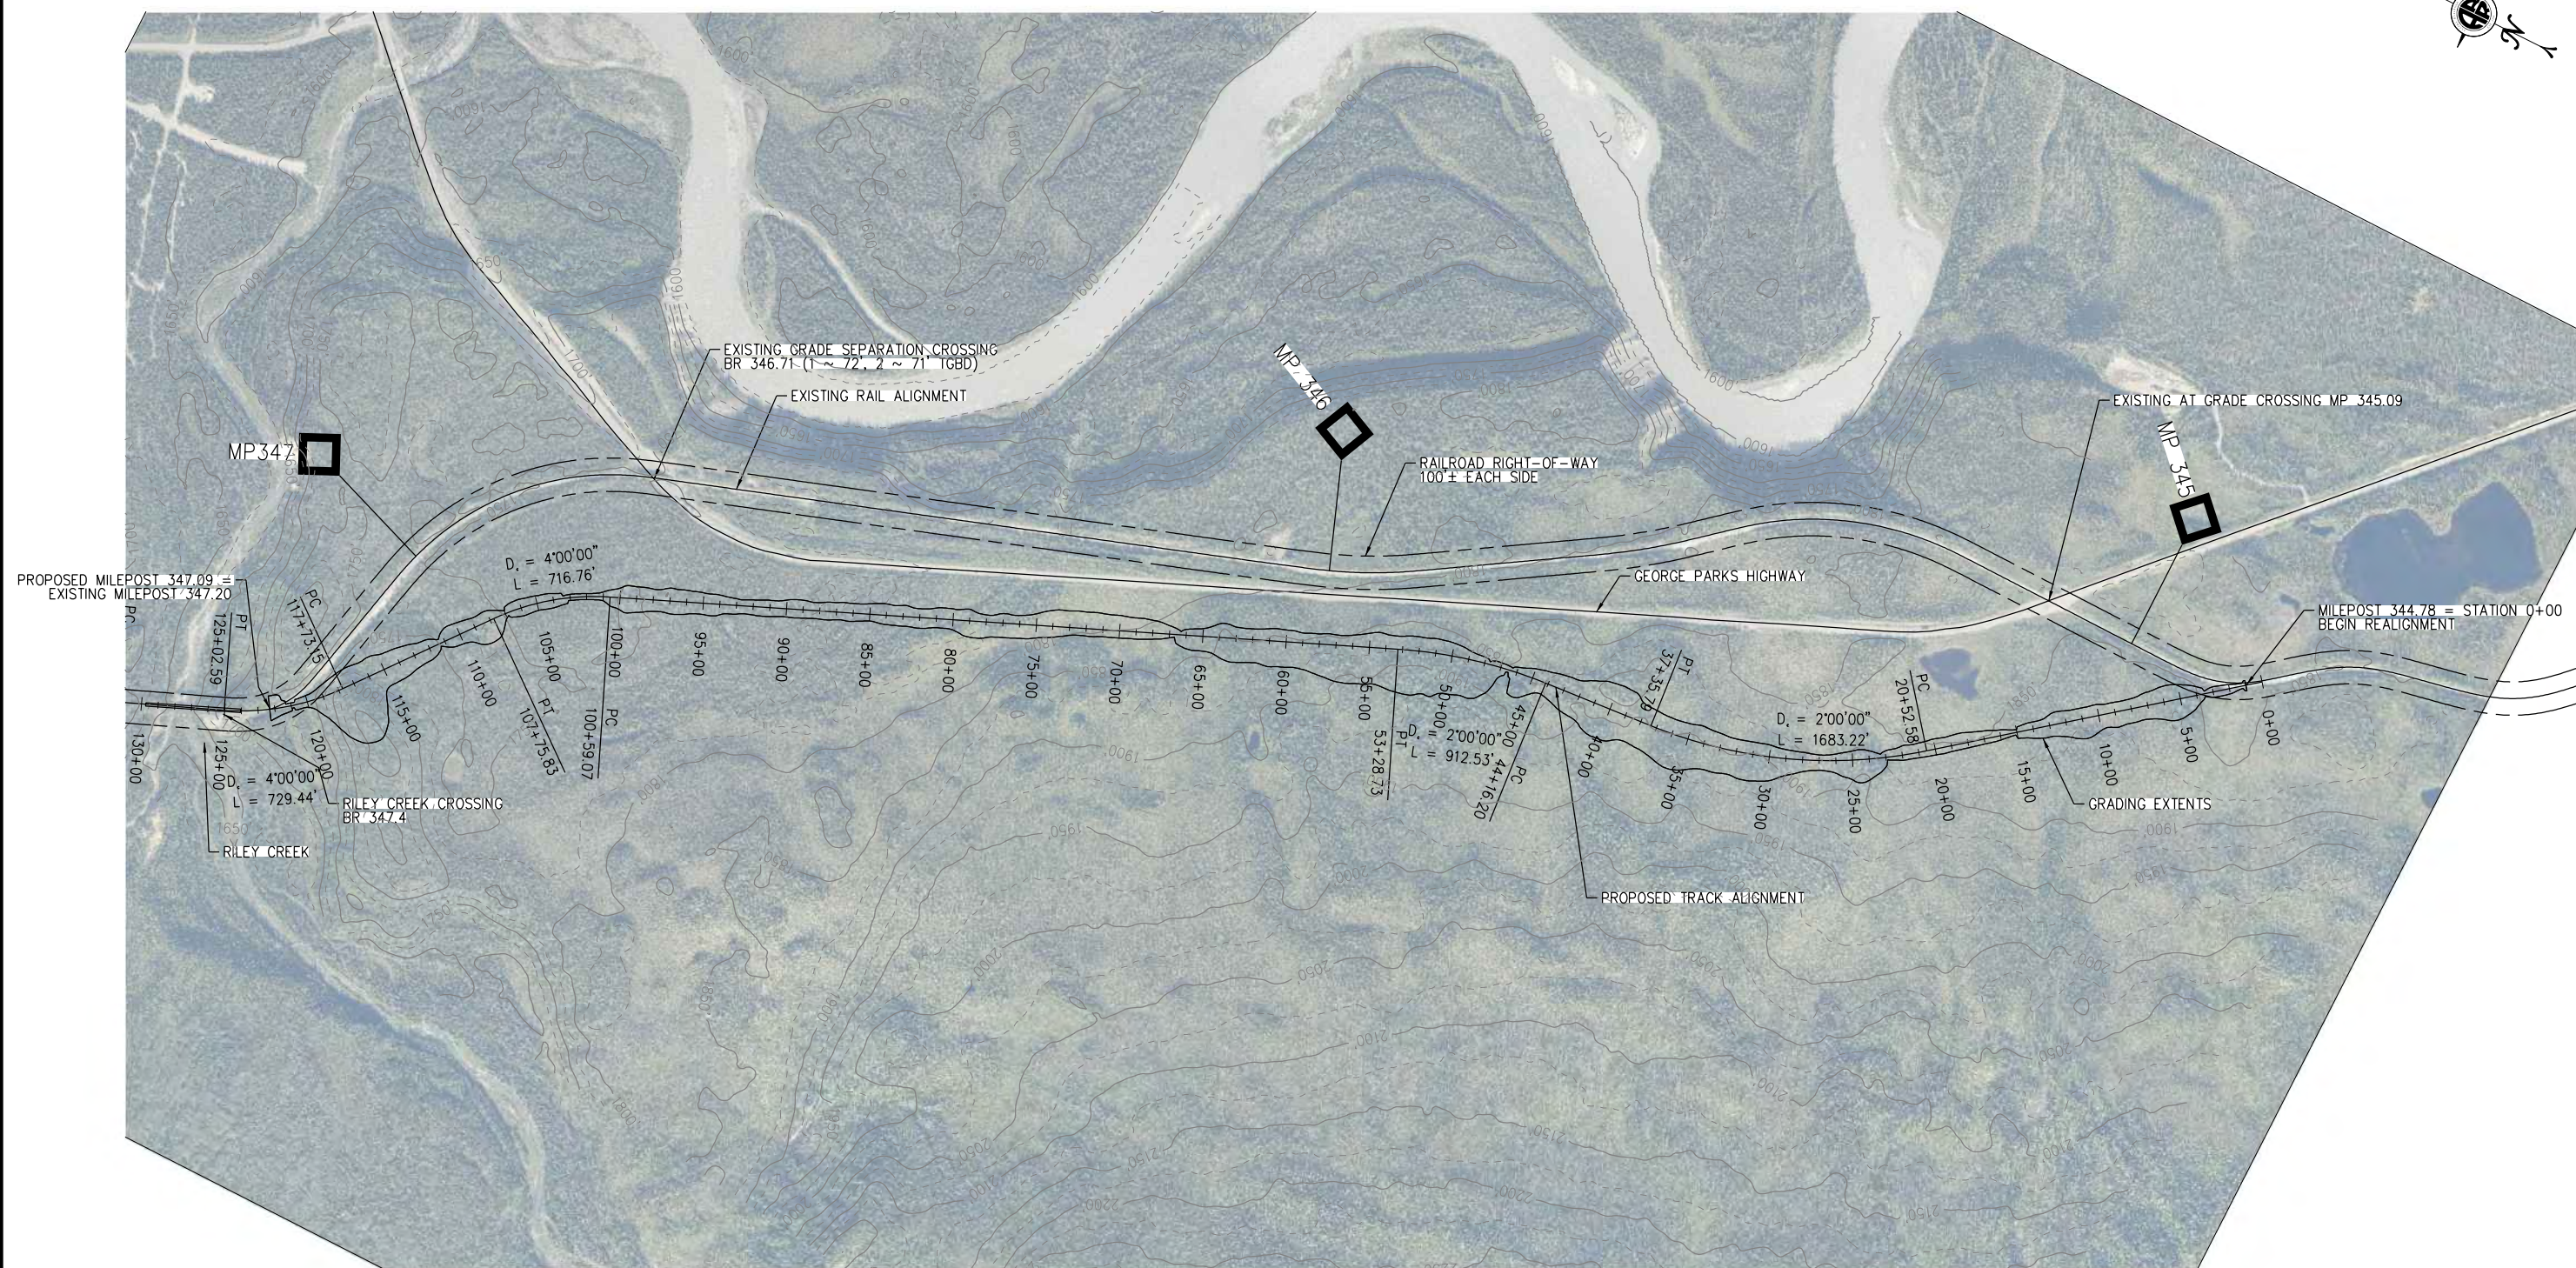
ALASKA RAILROAD			
PROJECT : DENALI PARK REALIGNMENT FEASIBILITY STUDY MP 344-348			
TITLE : ALTERNATIVE 1 - REALIGN TRACK THROUGH THE PARK PLAN VIEW			
DESIGNED BY: CPH	SCALE: AS NOTED	AFE NO.:	
DRAWN BY: AEP	DATE: 07/13/2018	ACAD FILE:	
CHECKED BY: CPH		DWG NO.:	2 OF 7
APPROVED BY:

PROPOSED MILEPOST 347.09 =
EXISTING MILEPOST 347.20

Alternative 1 – Rail Realignment would reduce the curvature of the rail alignment, thereby improving overall operations. Curved track can be more than ten times as expensive to maintain as straight track.²⁰ As trains travel around curves, lateral forces develop. These lateral forces require a stronger track structure and a higher standard of maintenance. Curved tracks also accelerate wear in railcar wheels, the rail, and the ties, and cause breakdown of the track ballast.²¹

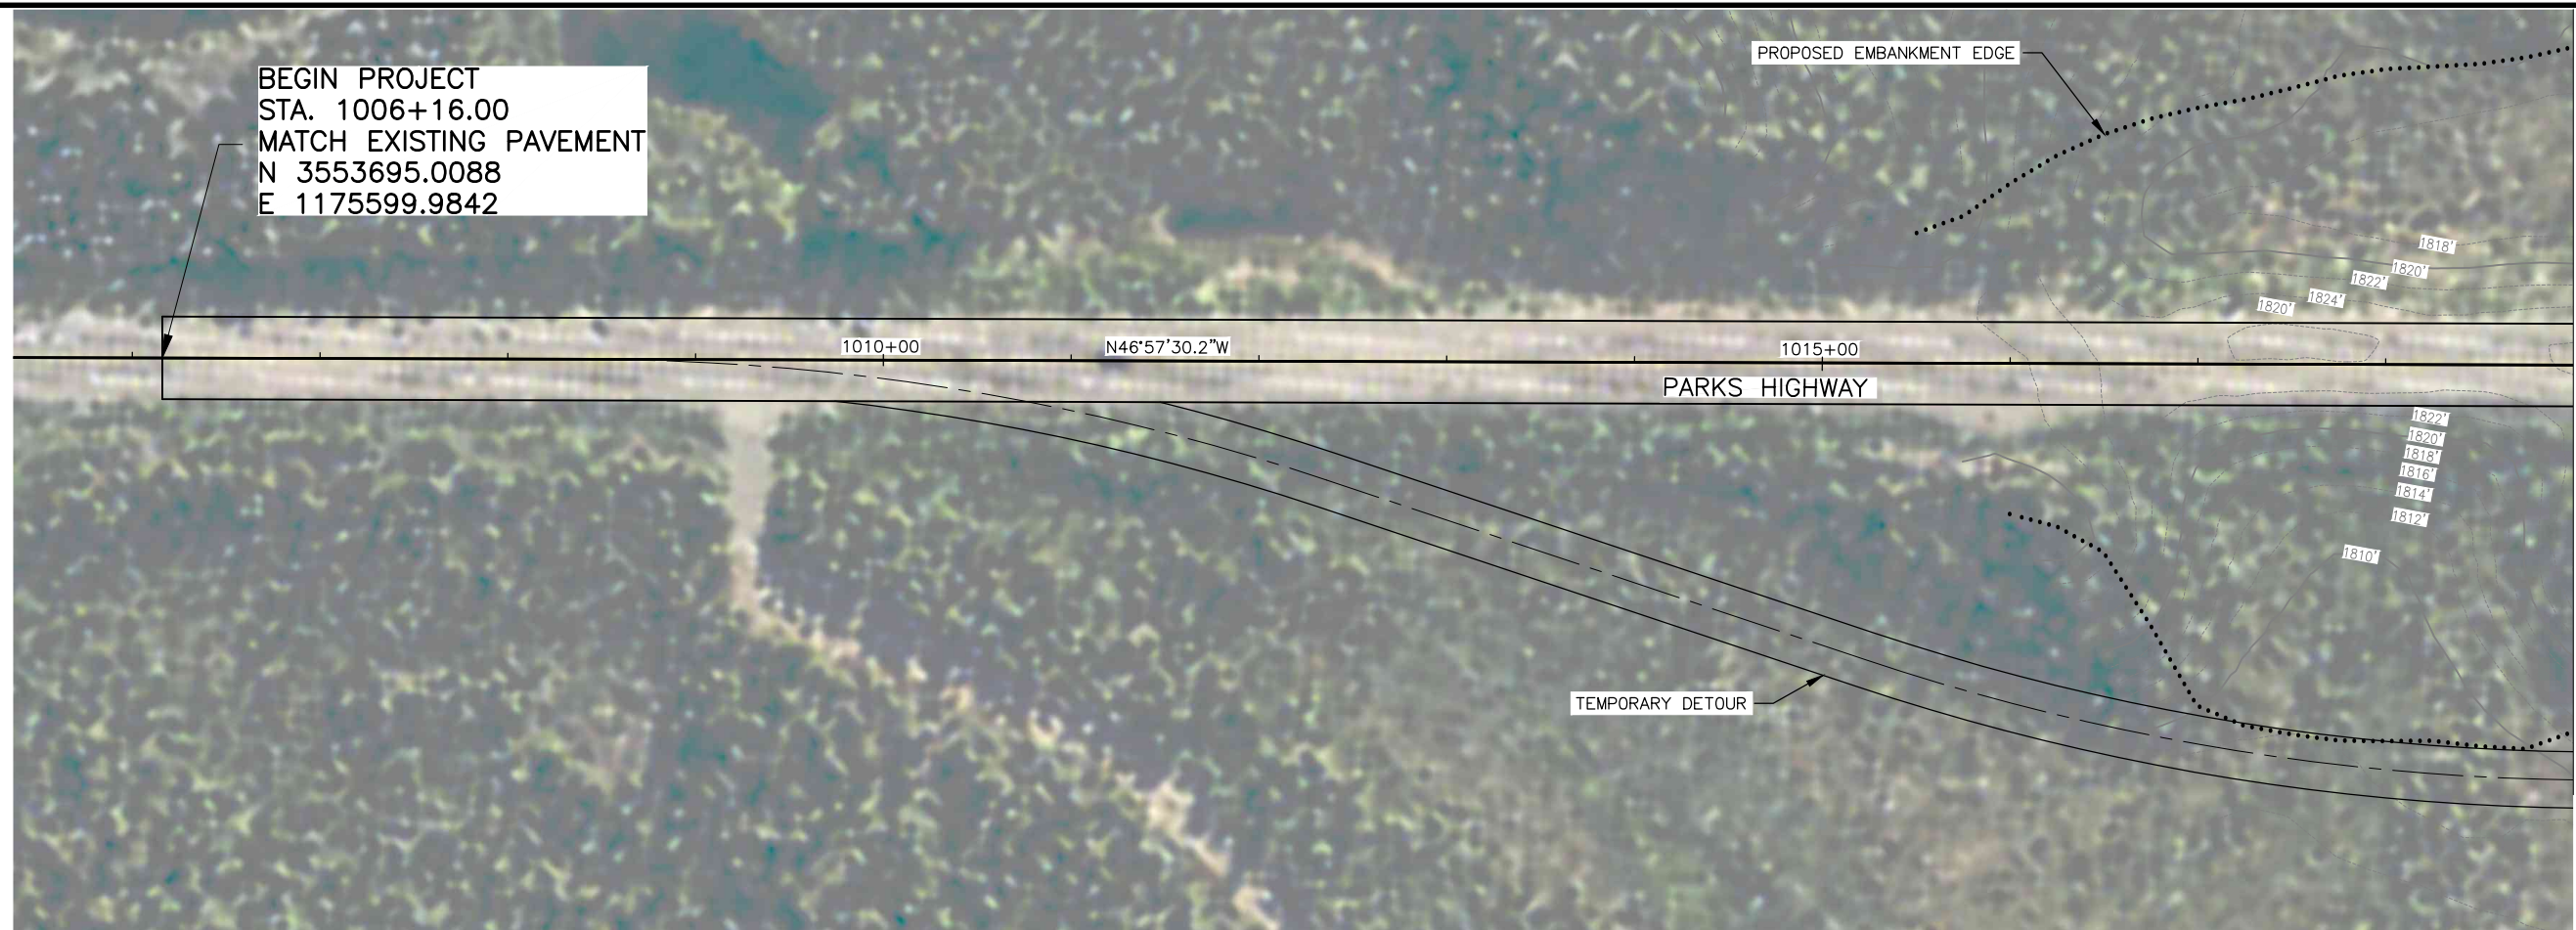
ALASKA RAILROAD			
PROJECT: DENALI PARK REALIGNMENT FEASIBILITY STUDY MP 344-348			
TITLE: ALTERNATIVE 3 GRADE SEPARATE MP 345.09			
DESIGNED BY: TCP	SCALE:	AFE NO.:	
DRAWN BY: TCP	DATE:	ACAD FILE:	
CHECKED BY: CPH		DWG NO.:	
APPROVED BY:			4 OF 7

TEMPORARY DETOUR

HIGHWAY PROFILE
 SCALE: H:1"=100'-0"
 V:1"=20'-0"
