Final Report: Material Site Investigations, Dunbar Siding to Livengood Railroad Extension Route, Interior Alaska

June 6, 2011

Thomas K. Bundtzen, Paul A. Metz, Greg Laird, Cristina Laird, Peppi Bolz, Kyle Obermiller, and Matthew Billings

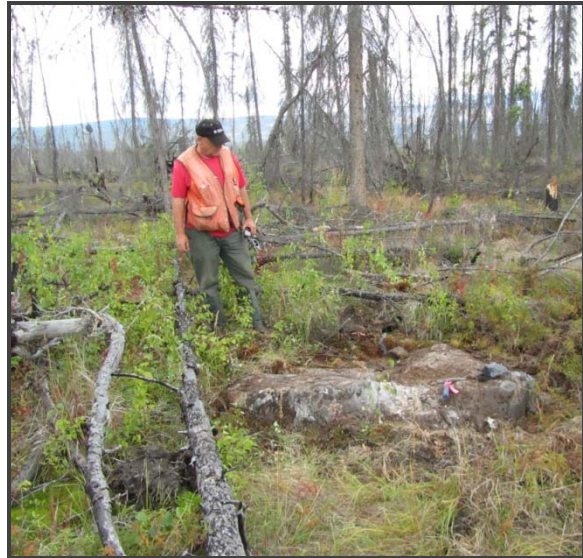
Right: PRGCI geologist Greg Laird inspects an outcrop of dark gray, crackled Globe quartzite in a burned area near station #10GL121.

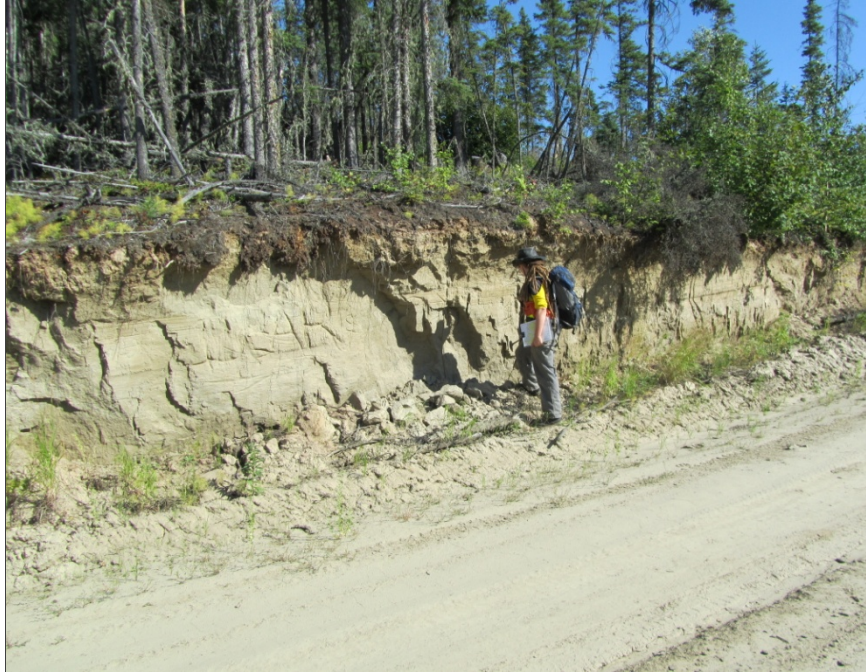
Figure 2 Peppi Bolz examines a thick loess deposit in the Standard Creek logging road complex, about six miles north-northeast of Dunbar; photo illustrates the thick deposits of eolian materials and vegetation that overlie much of the Dunbar-Livengood rail corridor

The entire project area is below timberline. Eolian silt covers virtually all of the landscape, but appears to thin along the route in a northerly direction (Figure 2). Bedrock control can be found on ridge tops and along steep bluffs where rivers cut into the topography (Figure 3). However, lower slopes are covered by an anastomosing network of alluvial-colluvial fan complexes.

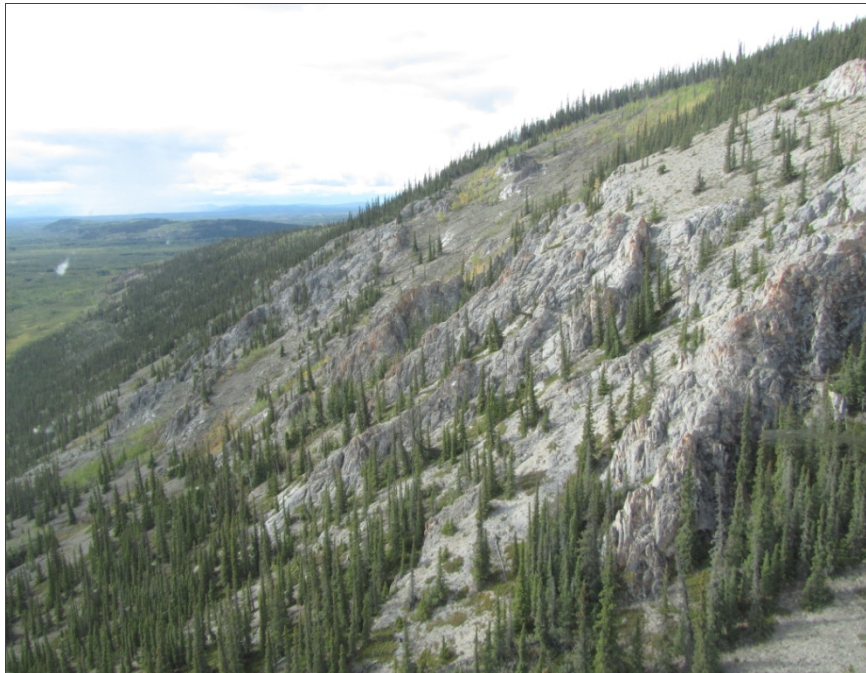
Figure 3 Outcrops of the Tolovana limestone unit (Dtr) at VABM Minto, illustrating some of the better exposed bedrock within the Dunbar-Livengood rail corridor

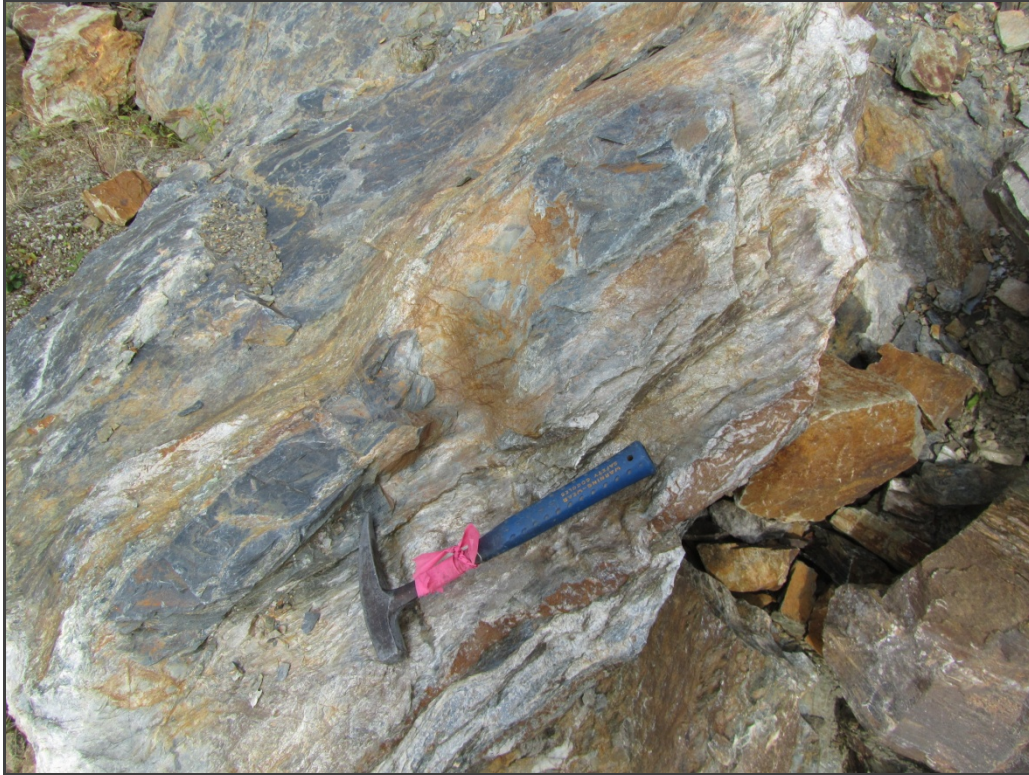
Figure 5 A rare exposure of Fairbanks schist at station #205100

A majority of the sites contained fine-to-medium grained, light gray, locally tan weathered, biotite-bearing, feldspathic, quartz-rich porphyro-clastic meta-sandstone (Figure 5). Interlocking, rounded, strained, quartz anhedra up to 0.3 mm form the dominant textural style (Figures 7, 8). Grains are sometimes marked by a fine dust of hematite(?). Isolated grains of both biotite and muscovite can be found throughout each thin section sampled, but they constitute only a small percentage of the total groundmass. Point count work from six (6) thin sections (sample numbers 204685, 205411, 205412, 204413, 205414, 205415) show the following compositions in percent: quartz: 88.0; biotite 5.0; muscovite 3.0; feldspar 1.0; amphibole 1.0; opaques (hematite) 1.5; and chlorite 0.5. The results from two major oxide analyses of the Fairbanks schist are shown in Table 2. The geochemical data shows that the samples are mostly composed of silica, with virtually nothing else, except 1.38% iron oxide, in sample #205242. Both rock samples can be classified as impure quartzite.

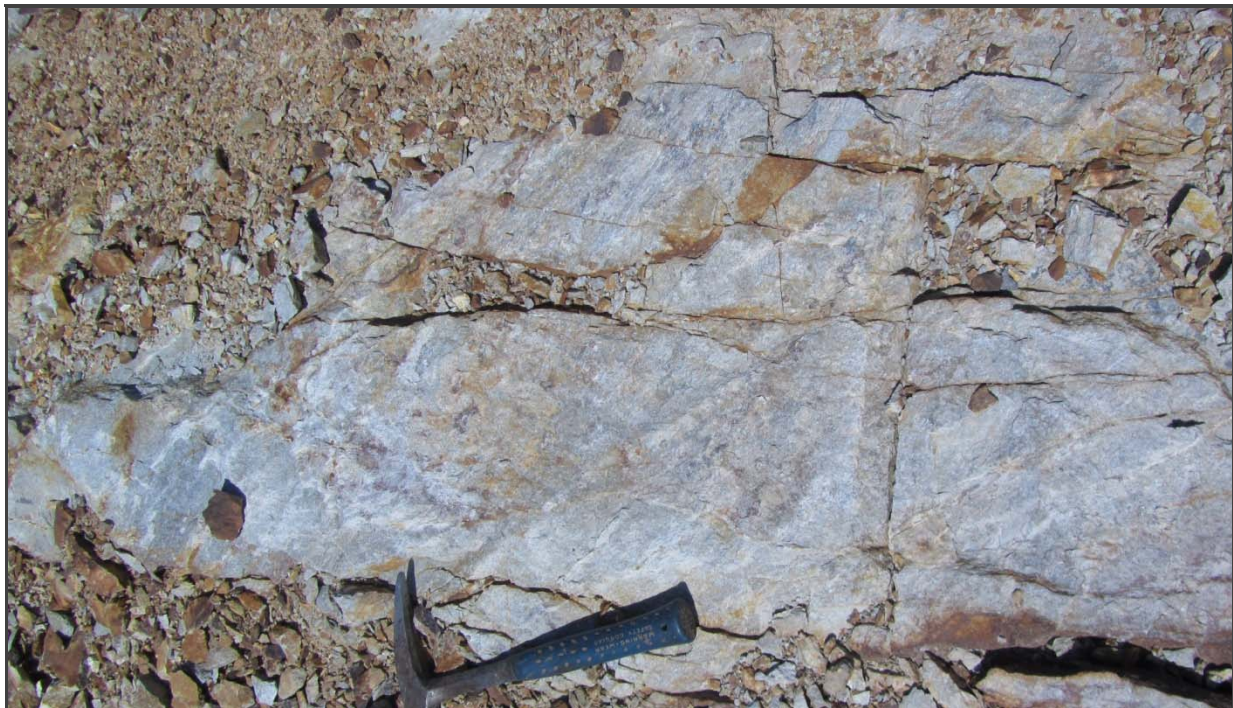
Figure 6 An outcrop of siliceous Fairbanks schist at station #205411, near VABM Luck, illustrating riprap potential

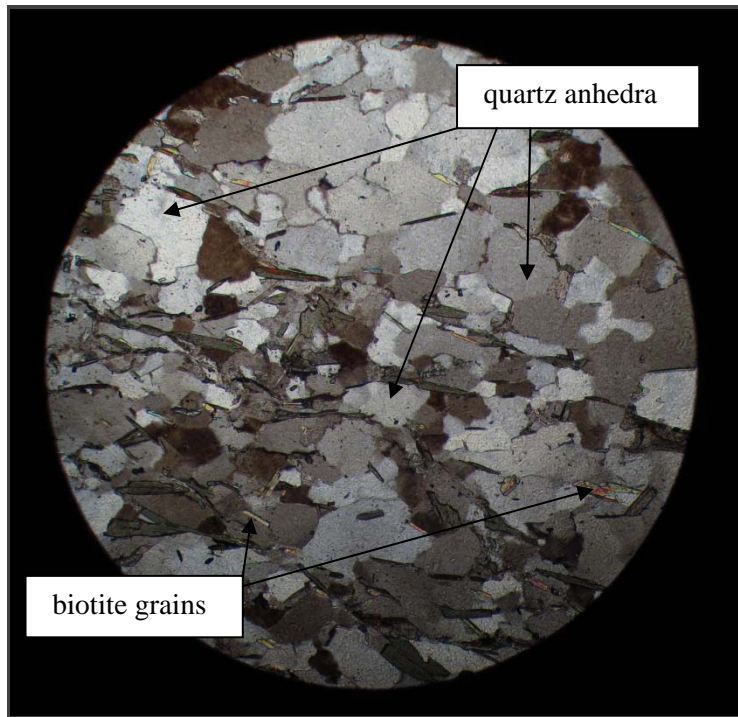
Figure 7 Photomicrograph of Fairbanks schist-quartzite from station #204685, crossed nicols, 100X, showing interlocking, strained quartz anheda and minor, isolated grains of biotite

Table 3 summarizes material test results from two samples. Sample #204685 had a high T-13 degradation value of 91 percent, a moderate Los Angeles abrasion loss value of 28 percent, and low sodium sulfate and water absorption values. In contrast were values from location #205242, which produced a T-13 degradation value of 44 percent, a Los Angeles abrasion loss value of 32 percent, and high water absorption and freeze/thaw soundness values. The former sample was from a nearly massive quartzite layer, and the latter sample was from a more micaceous, quartzose schist zone.

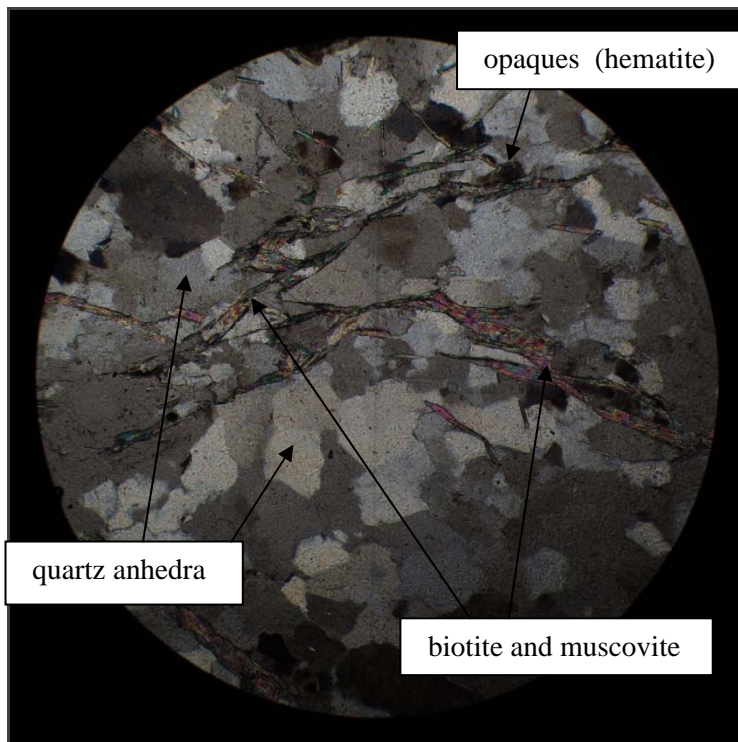
Figure 8 Photomicrograph of Fairbanks schist-quartzite from station #205242, crossed nicols, 100X, showing interlocking, strained quartz anheda with biotite and muscovite following structural zones, i.e., late cleavage

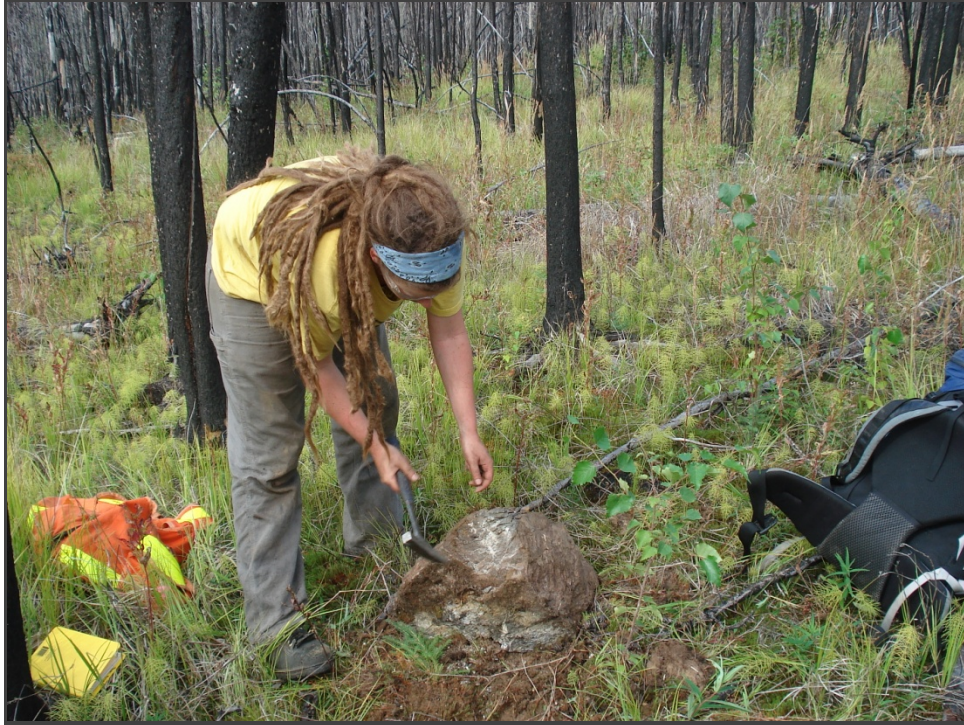
Figure 9 Massive sandstone Grit unit (float) at station #204938 in a burn area north of the Tatalina River

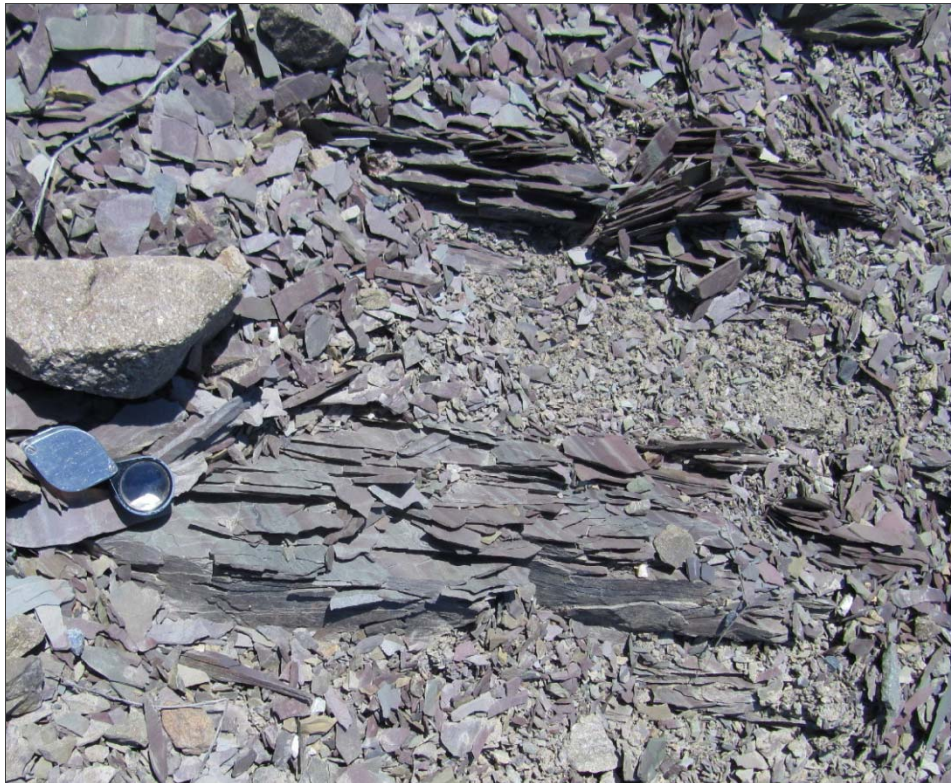
Figure 10 Wickersham Grit section at station #205418; note the friable maroon and green phylitic rocks

Very little structural data was collected from the Grit units during this study due to poor outcrop control. At sample site #205418, a parallel system of joints, striking north 70° east and dipping 70° northwest, cut the outcrops at a spacing of 4 inches or less. No riprap potential was observed at that station, or at any station in the Grit units during the 2010 field work.

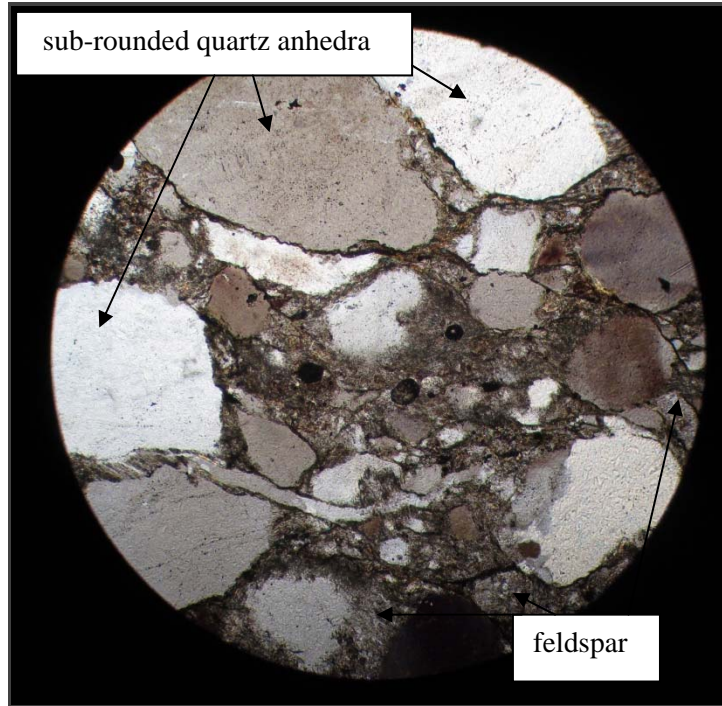
Figure 11 Photomicrograph of the Grit unit from station #204941, crossed nicols, 100X, showing interlocking, strained quartz anhedral, feldspar grains, and fine grained meta-clasts

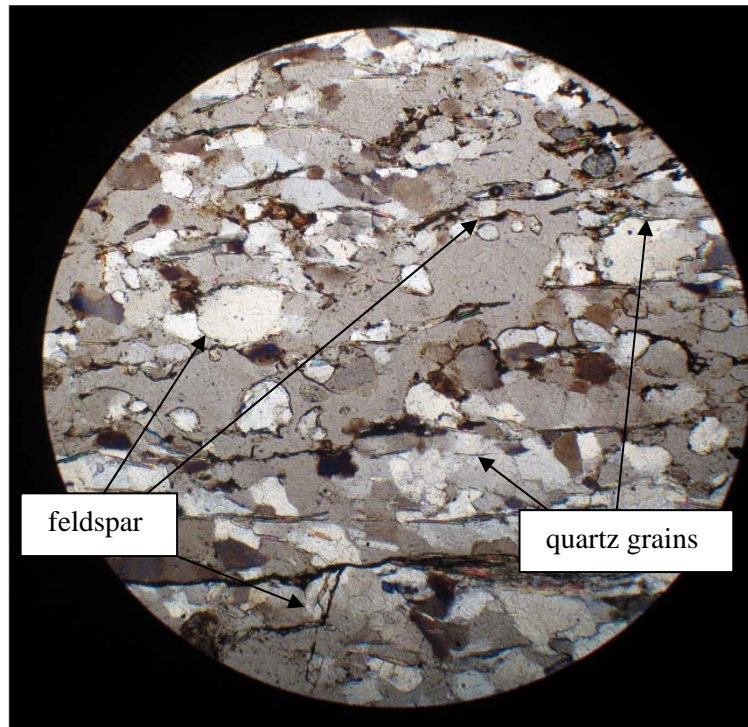
Figure 12 Photomicrograph of the Grit unit from station #204938, crossed nicols, 100X, showing interlocking, strained quartz anhedral, small feldspar grains, and fine grained quartz meta-clasts; the overall texture is similar to that observed in the Fairbanks schist; note the sub-parallel fractures in the groundmass with accompanying alteration

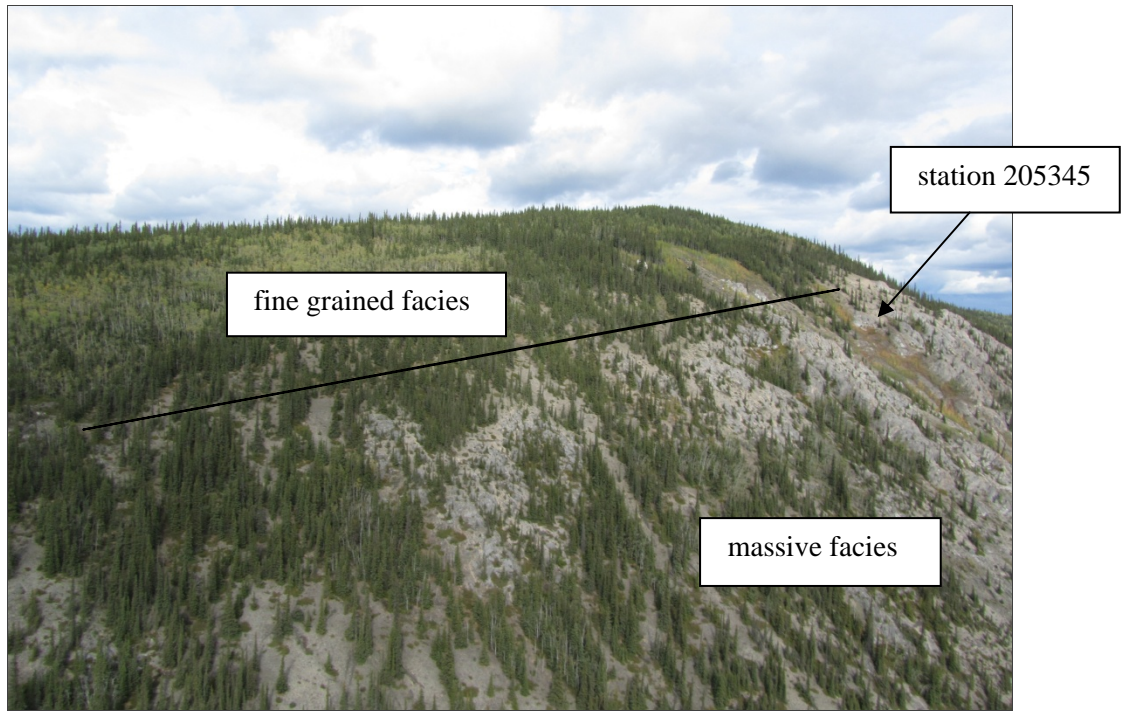
Figure 13 The lower slopes of VABM Minto, illustrating the more massive facies of the Tolovana limestone

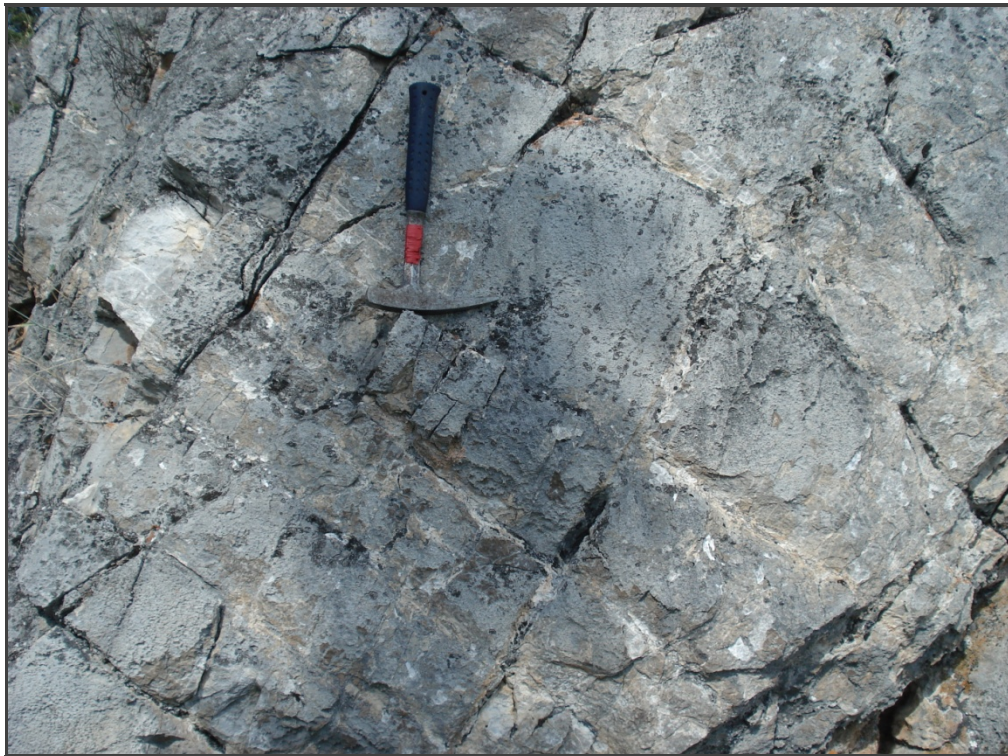
Figure 14 The massive facies of the Tolovana limestone at station #204933 in the rail corridor

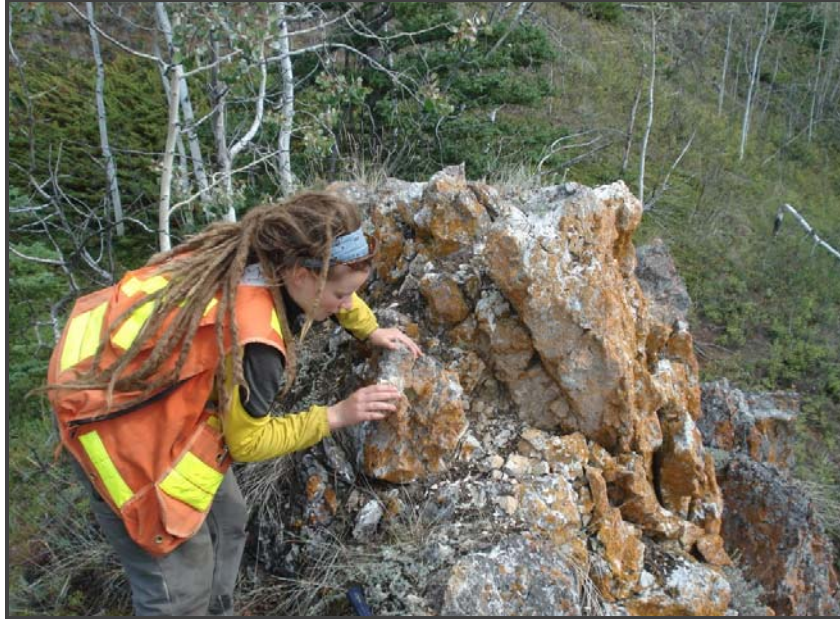
Figure 15 Peppi Bolz examines Tolovana limestone near the contact between the massive and fine grained facies at station #205929, south of VABM Minto

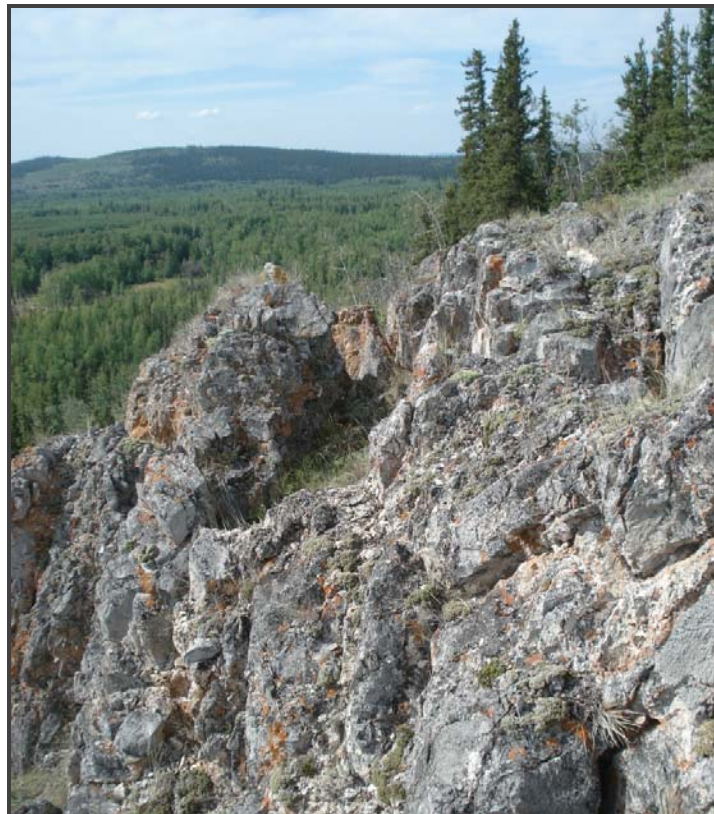
Figure 16 Massive facies Tolovana limestone at station #205931

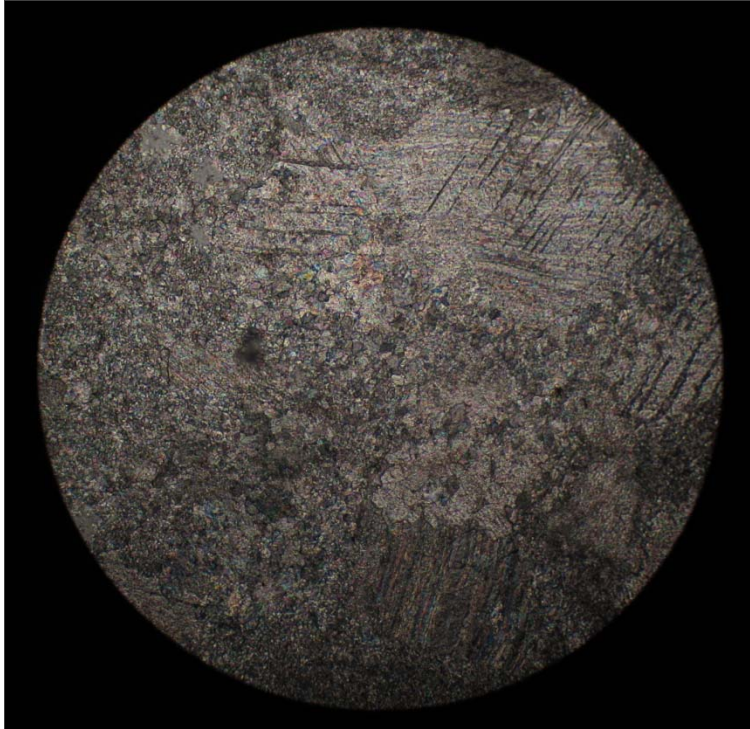
Figure 17 Photomicrograph of Tolovana limestone from station #204959, south of VABM Minto , crossed nicols, 100X; shows massive micrite - essentially large, pure, carbonate grains, without any other mineral grains

Major oxide analyses of two Tolovana limestone samples are summarized in Table 6. Although sample numbers 204959 and 204951 represent the massive micritic and laminated faces respectively, both are very similar geochemically. They are composed of nearly pure calcium carbonate, virtually devoid of impurities. Calcium carbonate equivalent values of 101.66 and 100.89 (in percent) after Barksdale (2001) were obtained for samples 204959 and 204951, respectively. The senior writer (Bundtzen) is unaware of the existence of more pure limestone compositions elsewhere in Alaskan limestone terranes.

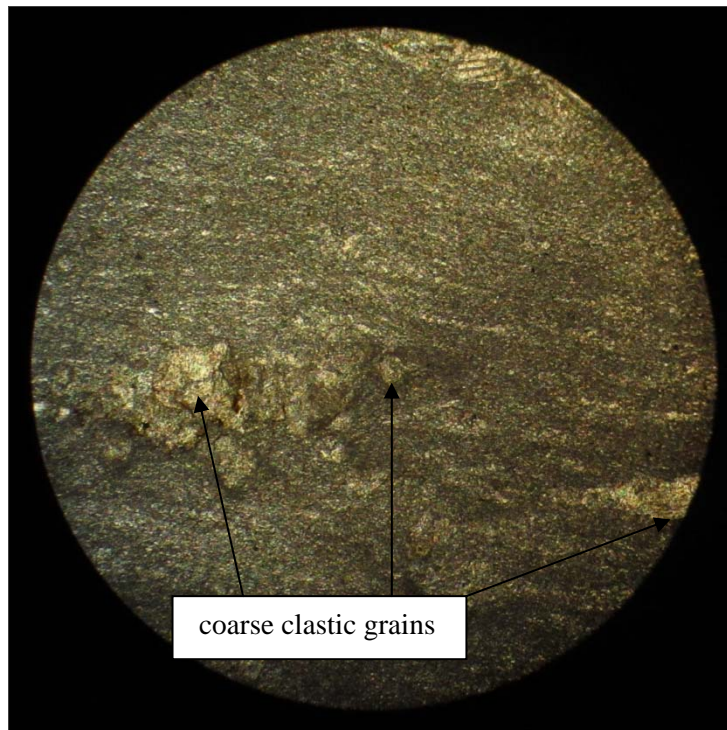
Figure 18 Photomicrograph of the Tolovana limestone from station #204951, southwest of VABM Minto , crossed nicols, 100X; shows laminated, fine grained facies; note some of the coarse grains are of clastic origin

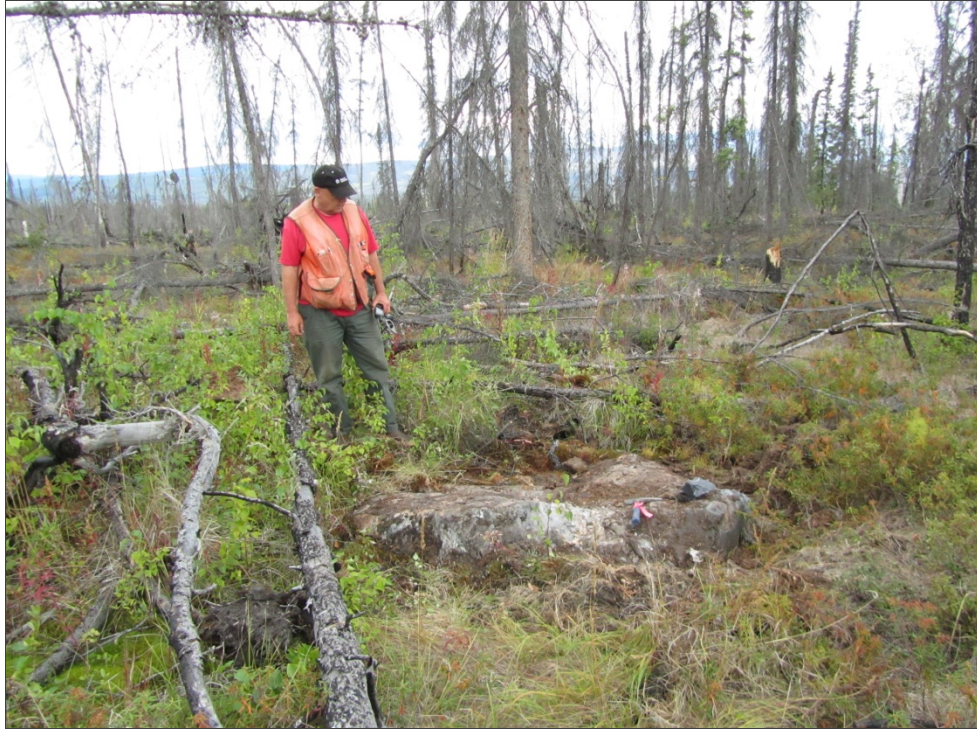
Figure 19 Greg Laird examines a subdued outcrop of Globe quartzite at station #205366, north of VABM Minto

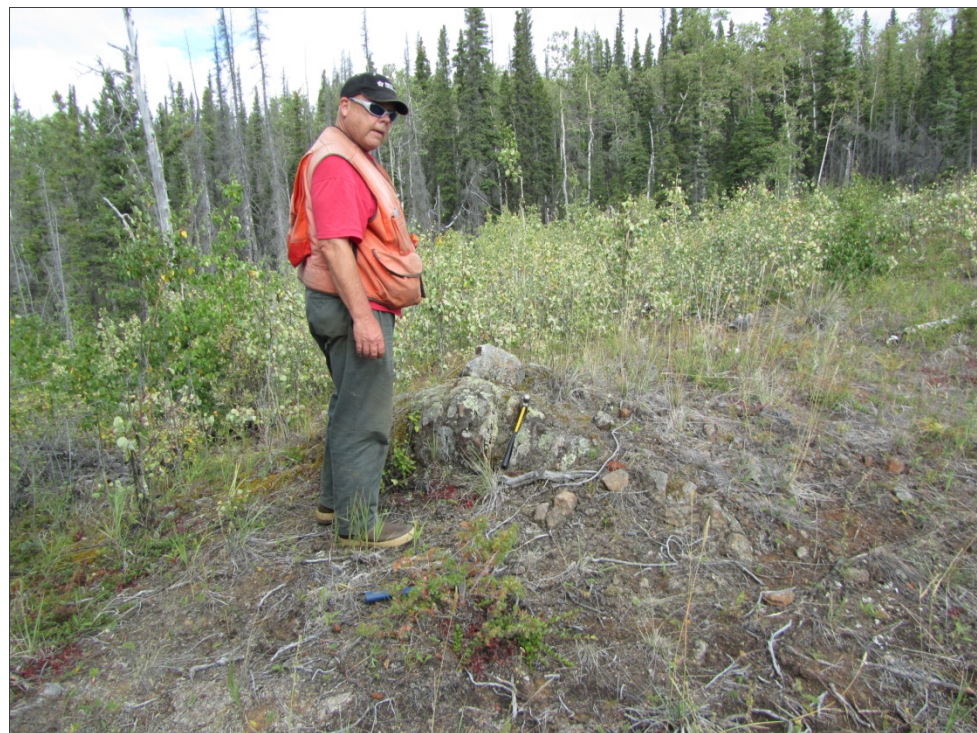
Figure 20 Greg Laird examines a subdued, fractured outcrop of Globe quartzite at station #205367

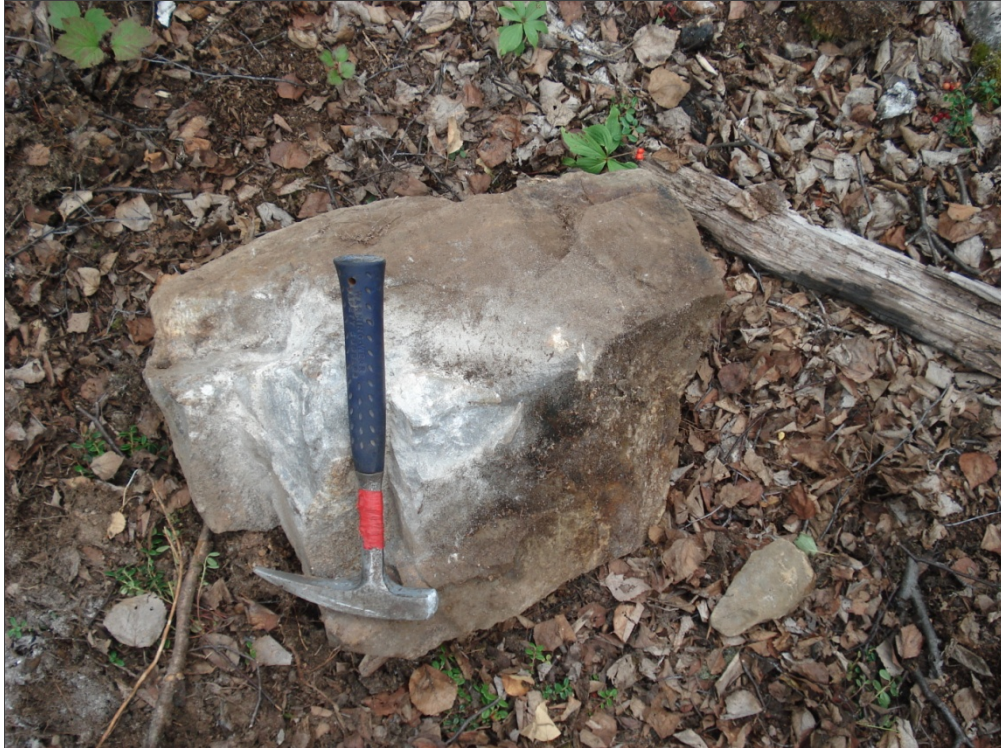
Figure 21 Globe quartzite boulder at station #205432, northwest of the Tatalina River

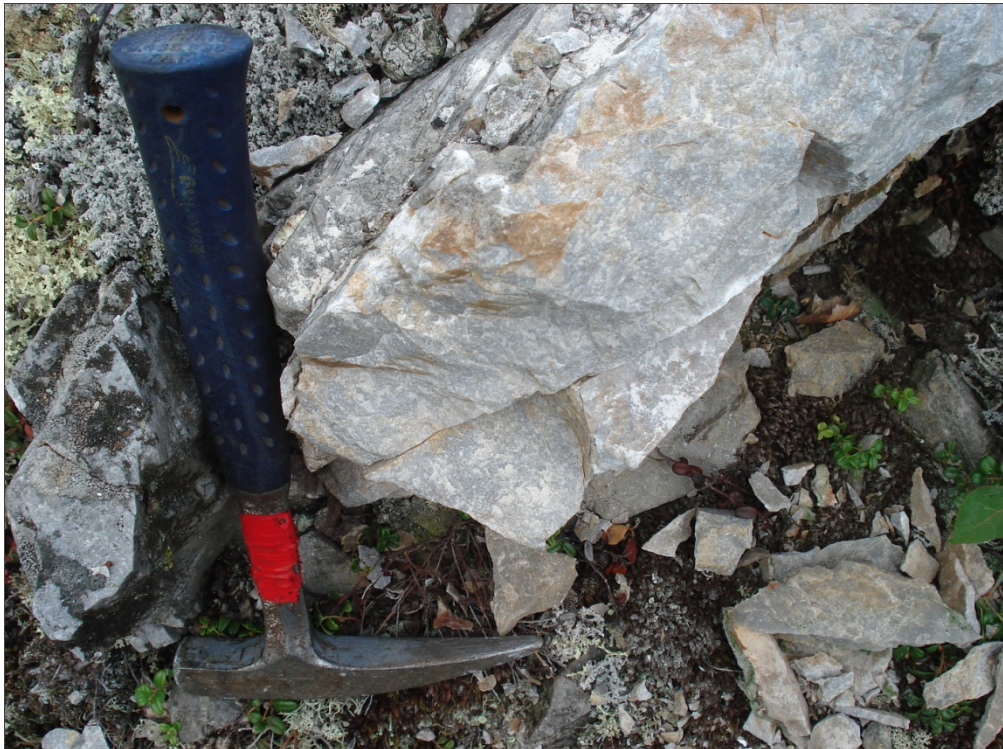
Figure 22 Rubble crop of Globe quartzite at station #205433, about eight miles northeast of station #205432

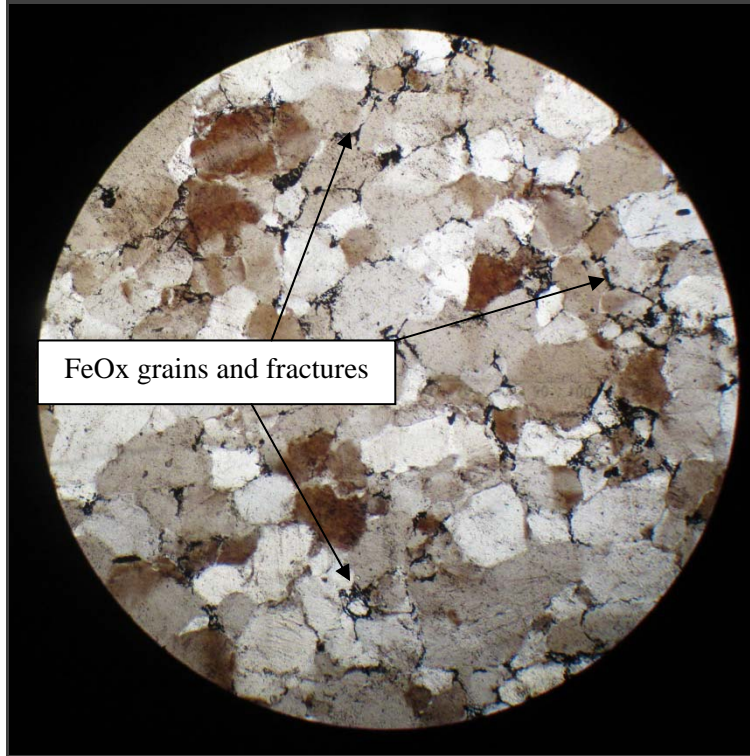
Figure 23 Photomicrograph of Globe quartzite from station #205367, crossed nicols, 100X; shows interlocking quartz anhedral and minor FeOx along fracture boundaries

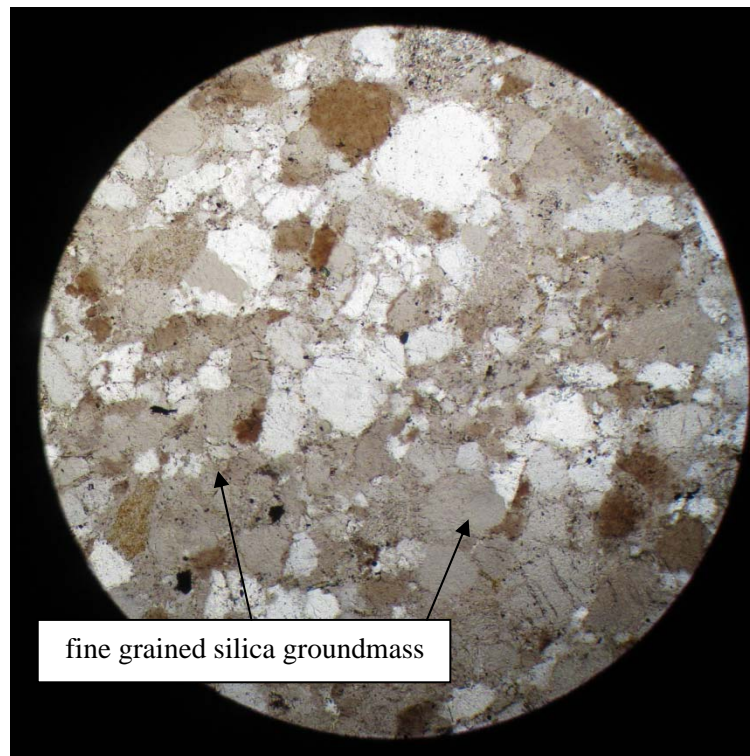
Figure 24 Photomicrograph of Globe quartzite from station #205371, crossed nicols, 100X; shows interlocking quartz anhedral with a finer grained, siliceous groundmass

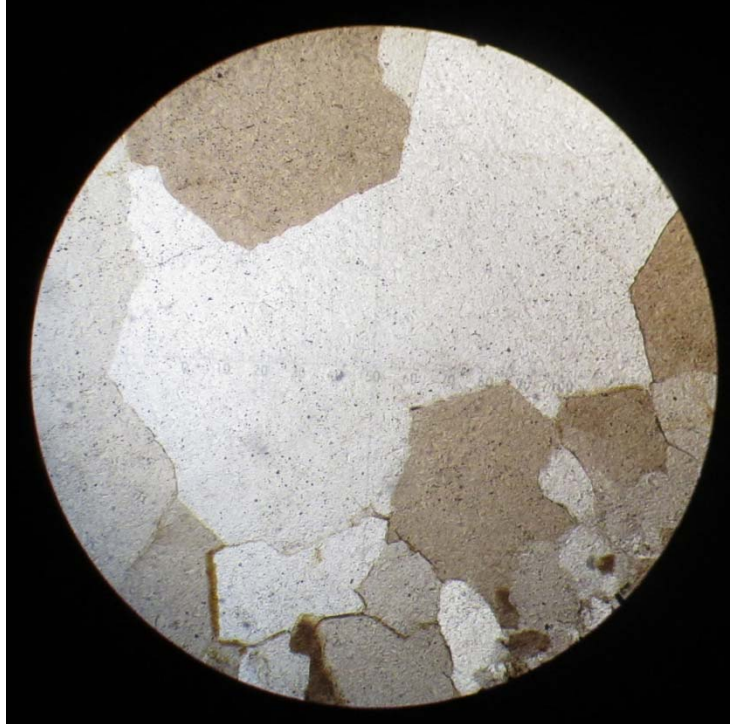
Figure 25 Photomicrograph of Globe quartzite from station #205432, crossed nicols, 100X; shows unusually coarse-grained, interlocking quartz anhedral

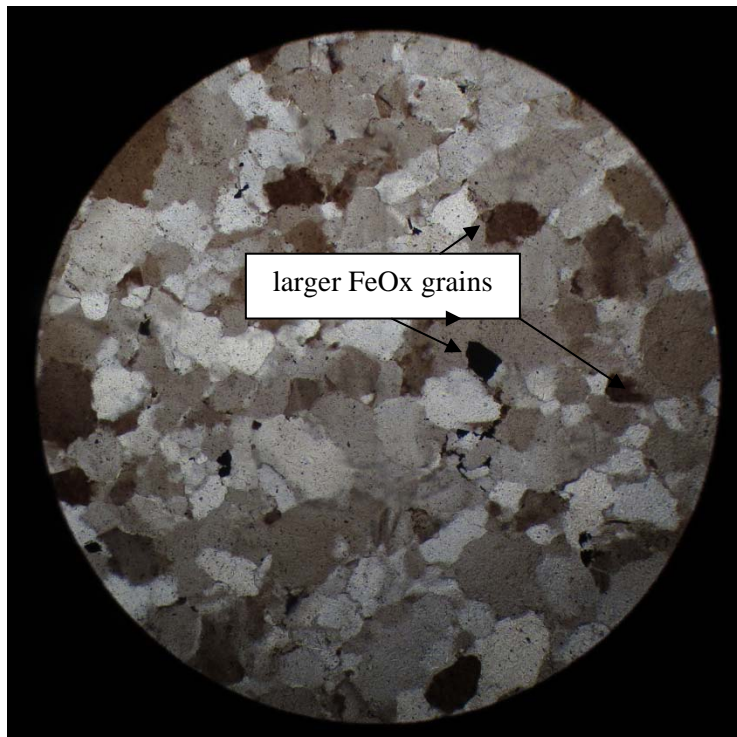
Figure 26 Photomicrograph of Globe quartzite from station #205433, crossed nicols, 100X; shows interlocking quartz anhedral and large, isolated, opaque iron oxide grains

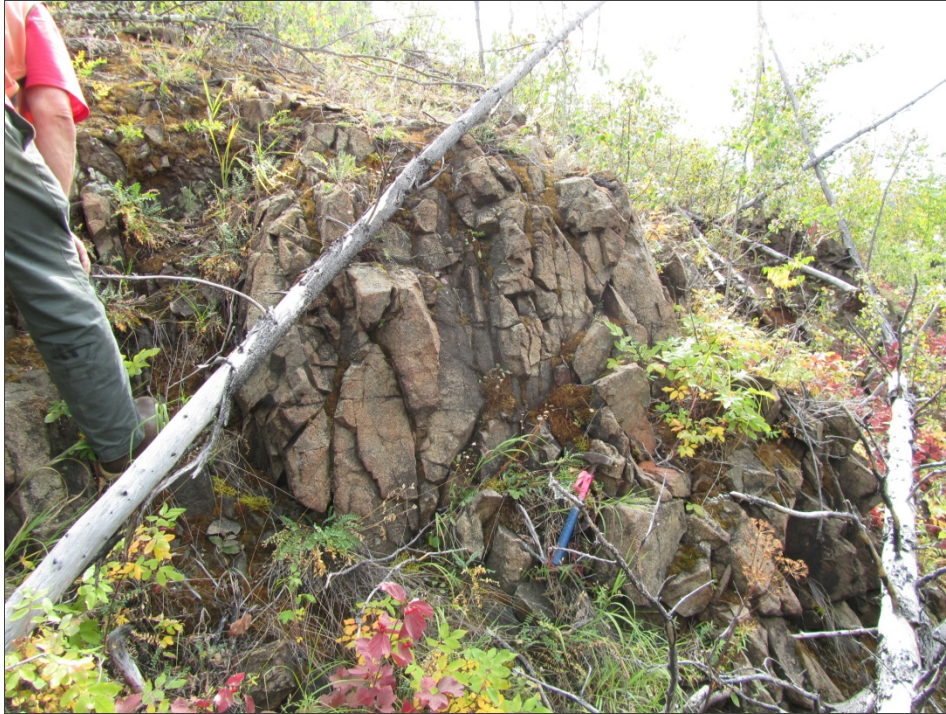
Figure 27 An outcrop of pyroxene gabbro at station #204960, illustrating joint and fracture arrangement, northwest of VABM Minto

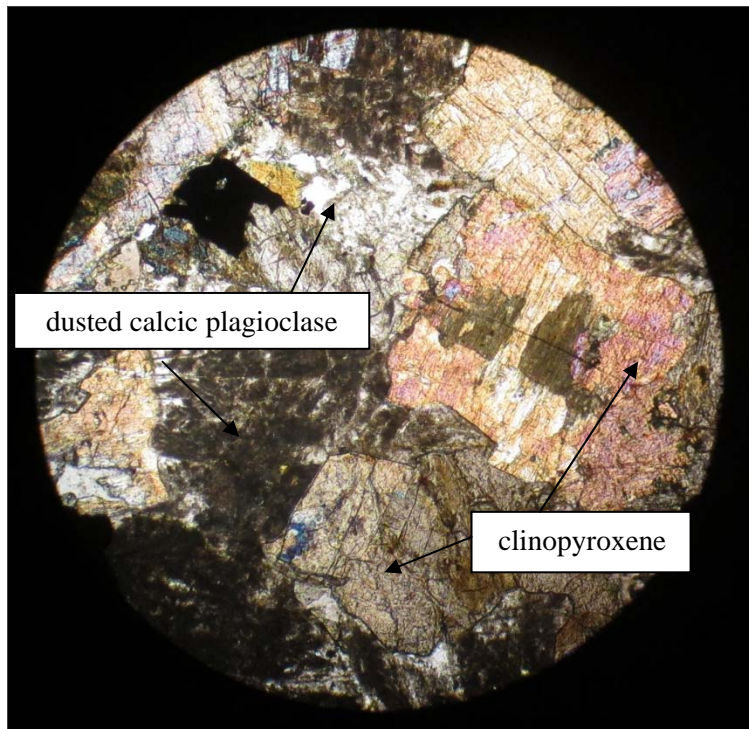
Figure 28 Photomicrograph of a gabbro sill complex (unit Trn) at station #204960, crossed nicols, 100X; shows large clinopyroxene grains altering to leucoxene, calcic-plagioclase, and opaques in hypidiomorphic texture

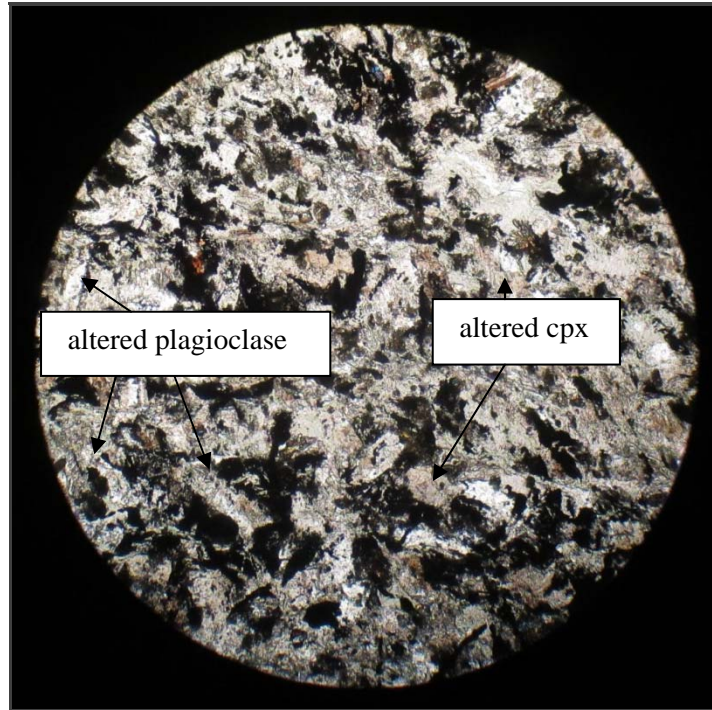
Figure 29 Photomicrograph of a gabbro sill complex (unit Trn) at station #205372, crossed nicols, 100X; near the Elliott Highway; shows clinopyroxene grains largely altered to antigorite, calcic-plagioclase altered to albite, chlorite, and carbonate, and abundant opaques after amphibole?

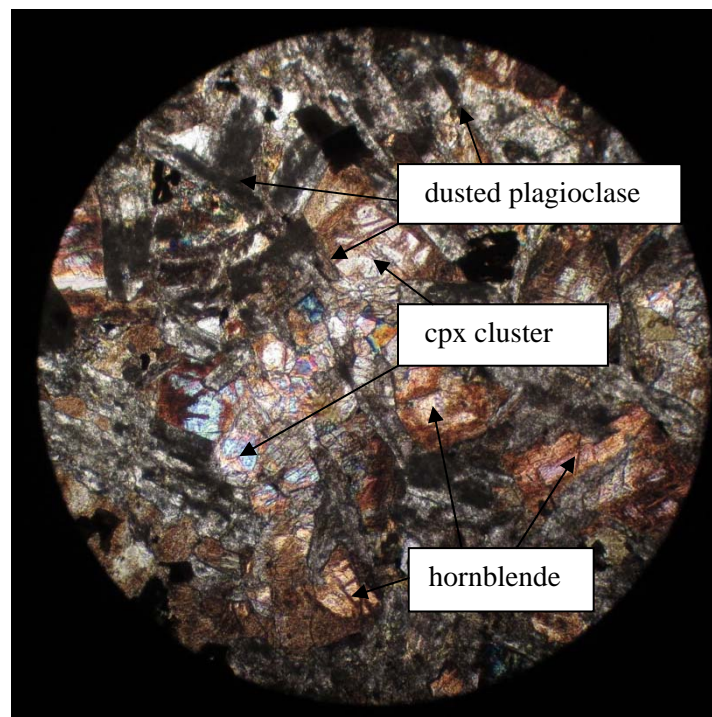
Figure 30 Photomicrograph of a gabbro sill complex (unit Trn) at station #205308, crossed nicols, 100X; shows both clinopyroxene and hornblende grains largely altered to antigorite, calcic-plagioclase (An57) altered to albite, chlorite, and carbonate, and opaque minerals now mainly iron oxides and leucoxene

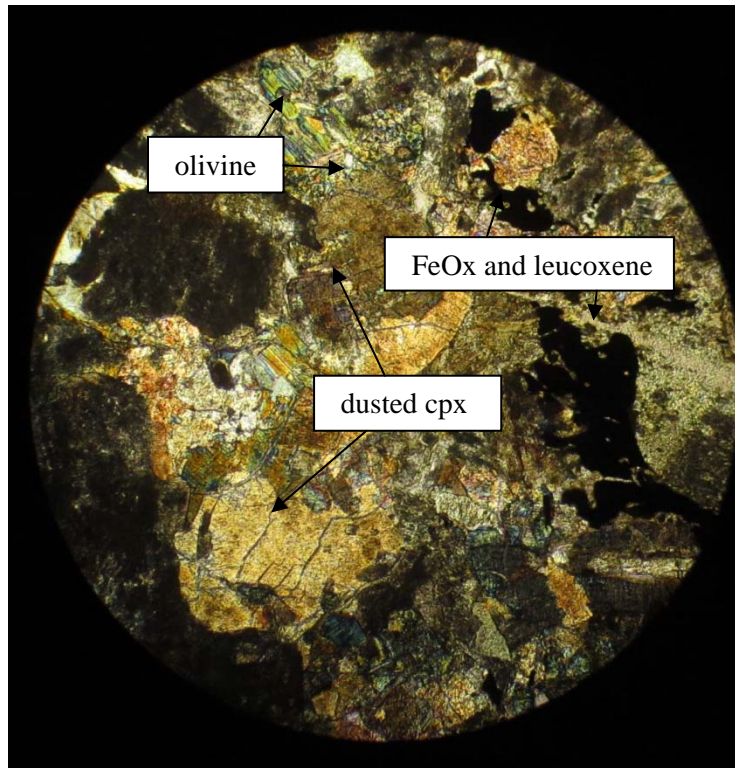
Figure 31 Photomicrograph of a gabbro sill complex (unit Trn) at station #205311, crossed nicols, 100X; shows both clinopyroxene grains largely altered to antigorite, small olivine grains altered to iddingsite, calcic-plagioclase altered to albite and chlorite and carbonate, and opaque minerals now mainly iron oxides and leucoxene

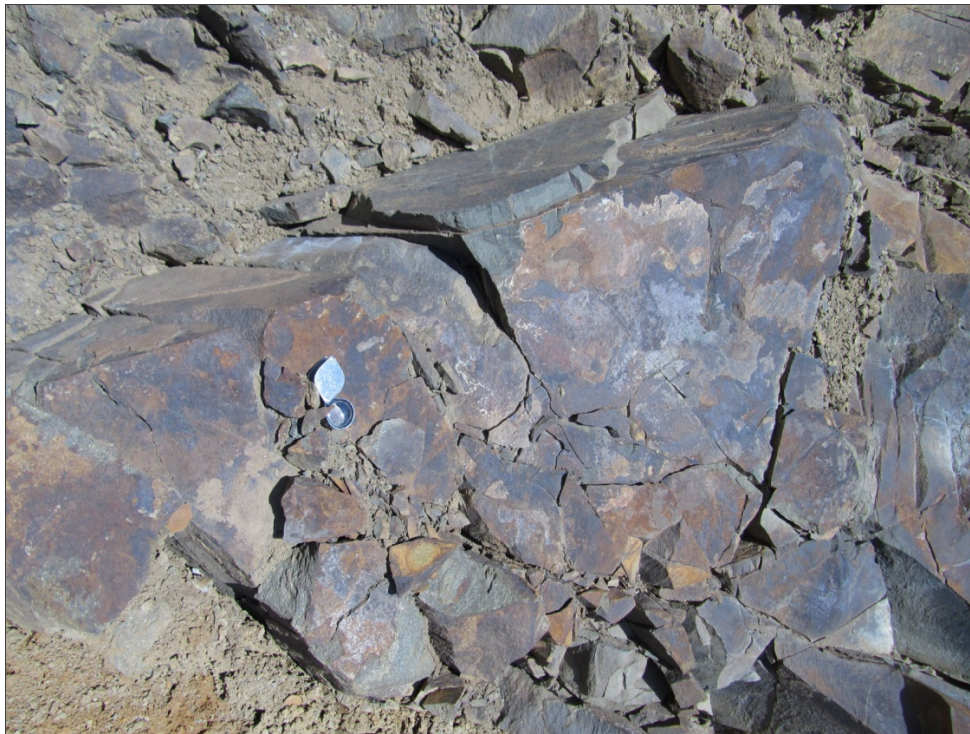
Figure 32 The massive facies of the Wilbur Creek flysch at station #205419; the flysch shows the effects of hornfels - note the joints

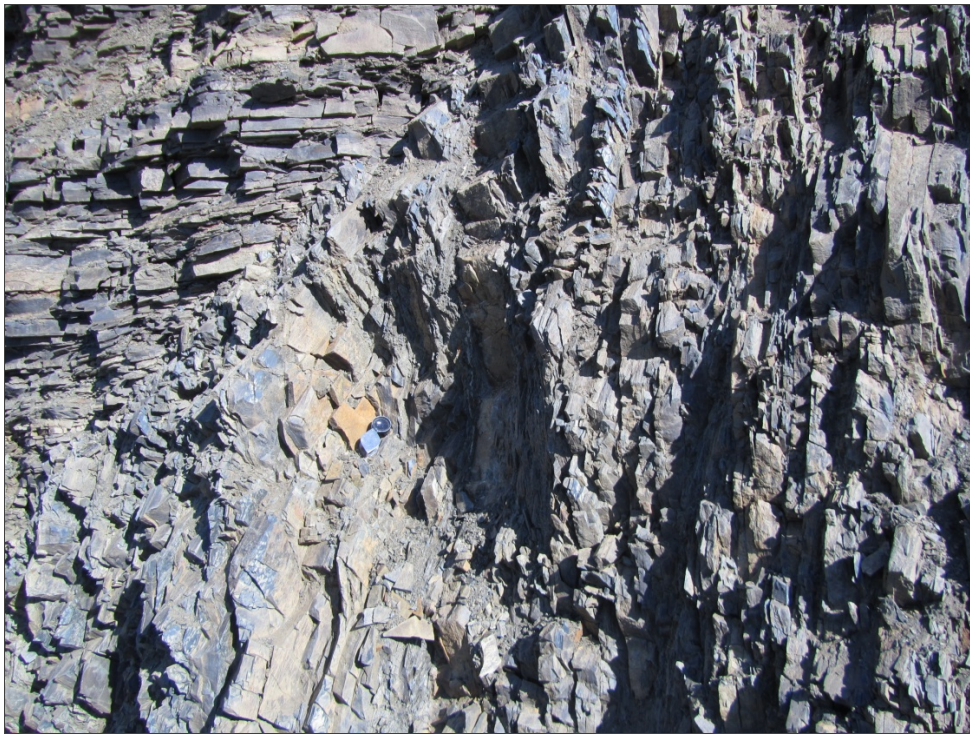
Figure 33 The thin bedded facies of the Wilbur Creek flysch at station #205418 - note the fold deformation

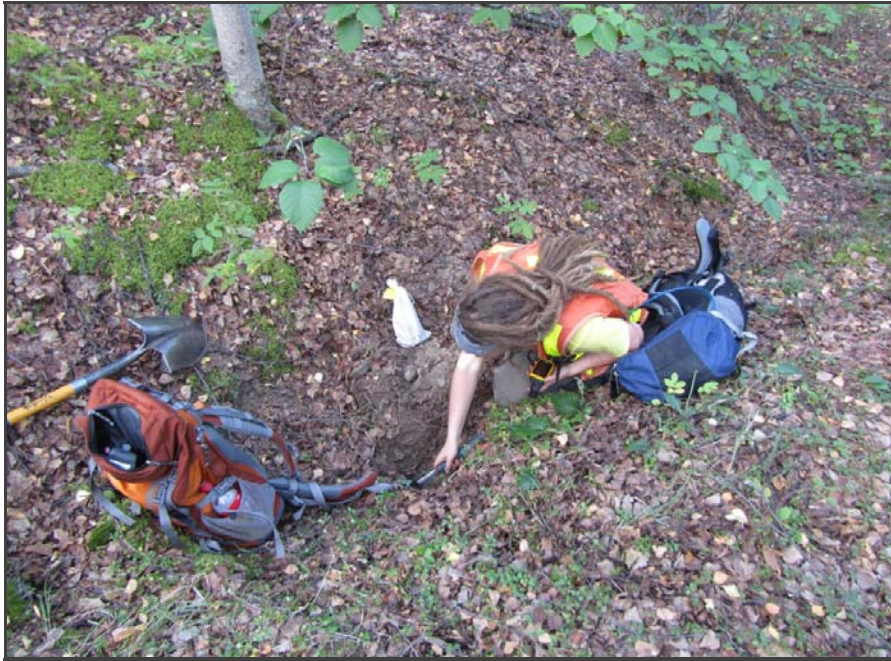
Figure 34 Peppi Bolz digging for bedrock control for the Wilbur Creek flysch unit (Kwsf) at station #205328 - a typical exposure for this unit
