Final Report: Material Site Investigations, Dunbar Siding to Livengood Railroad Extension Route, Interior Alaska

June 6, 2011

Thomas K. Bundtzen, Paul A. Metz, Greg Laird, Cristina Laird, Peppi Bolz, Kyle Obermiller, and Matthew Billings

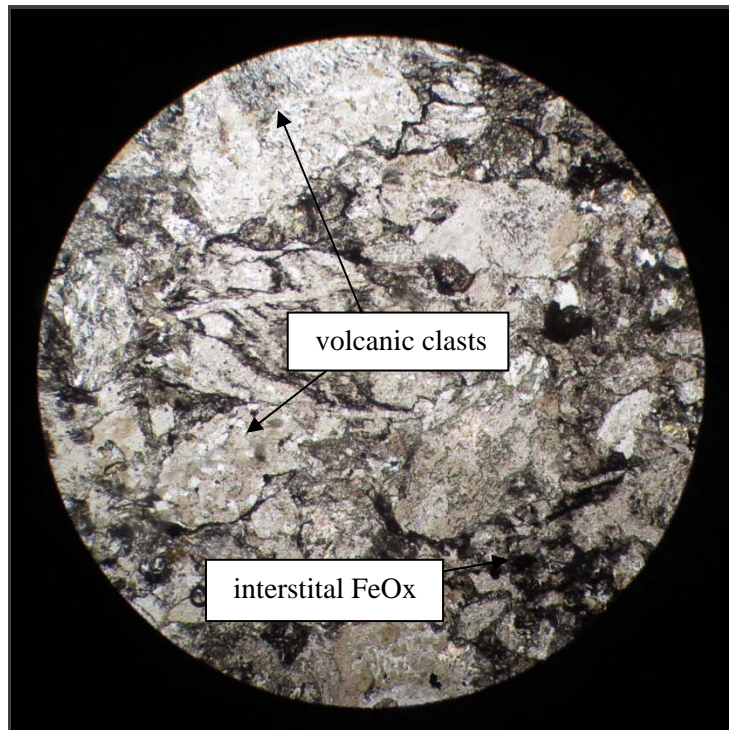
Figure 35 Photomicrograph of coarse grained Wilbur Creek flysch unit (Kwcf) from station #205324, plane light, 100X; shows the immature groundmass typical of the lithic sandstones of this unit; note the volcanic clasts

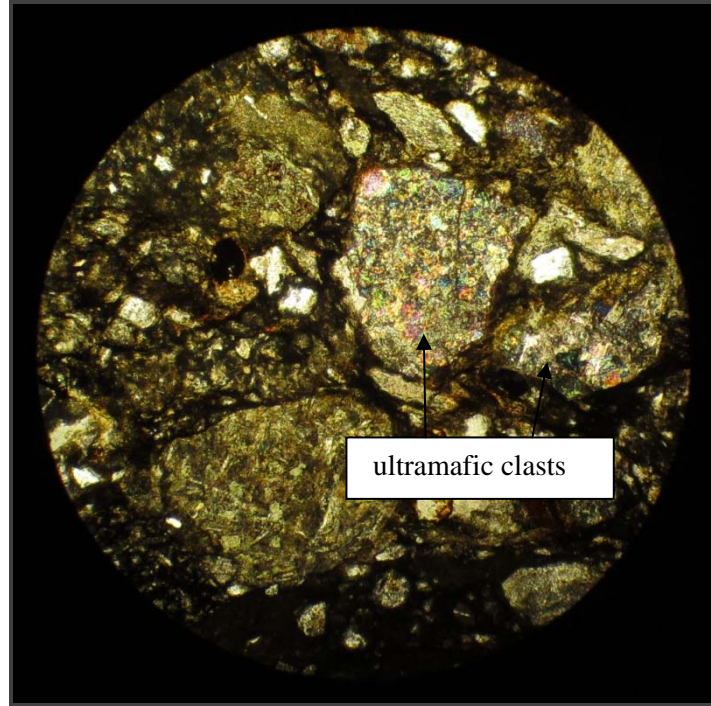
Figure 36 Photomicrograph of coarse grained Wilbur Creek flysch unit (Kwcf) from station #205421, crossed nicols, 100X; shows the immature groundmass typical of the lithic sandstones of this unit; note the clasts of ultramafic rock - probably derived from the Cambrian ophiolite unit; this sight also shows the effects of thermal metamorphism (hornfels)

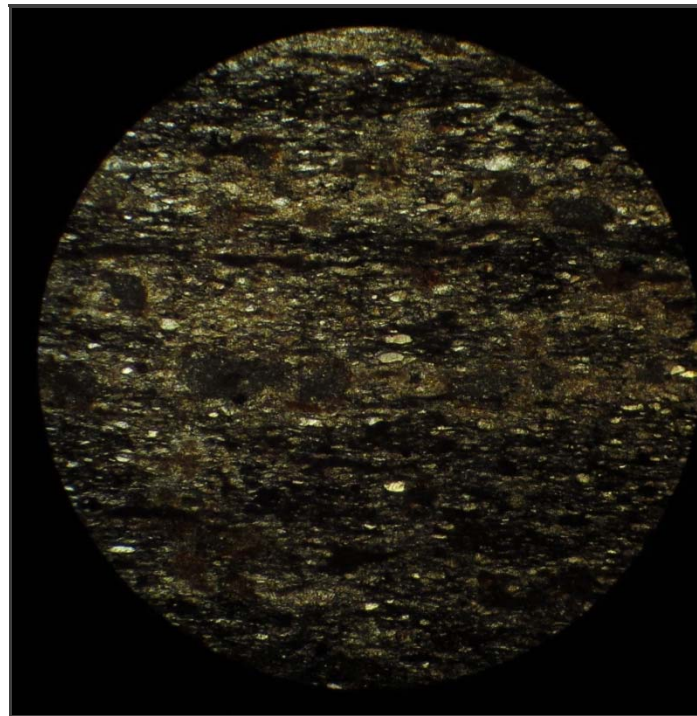
Figure 37 Photomicrograph of hornfels from the Wilbur Creek flysch unit (Kwcf) from station #205319, crossed nicols, 100X; shows the fine grained, 'welded' groundmass typical of this unit

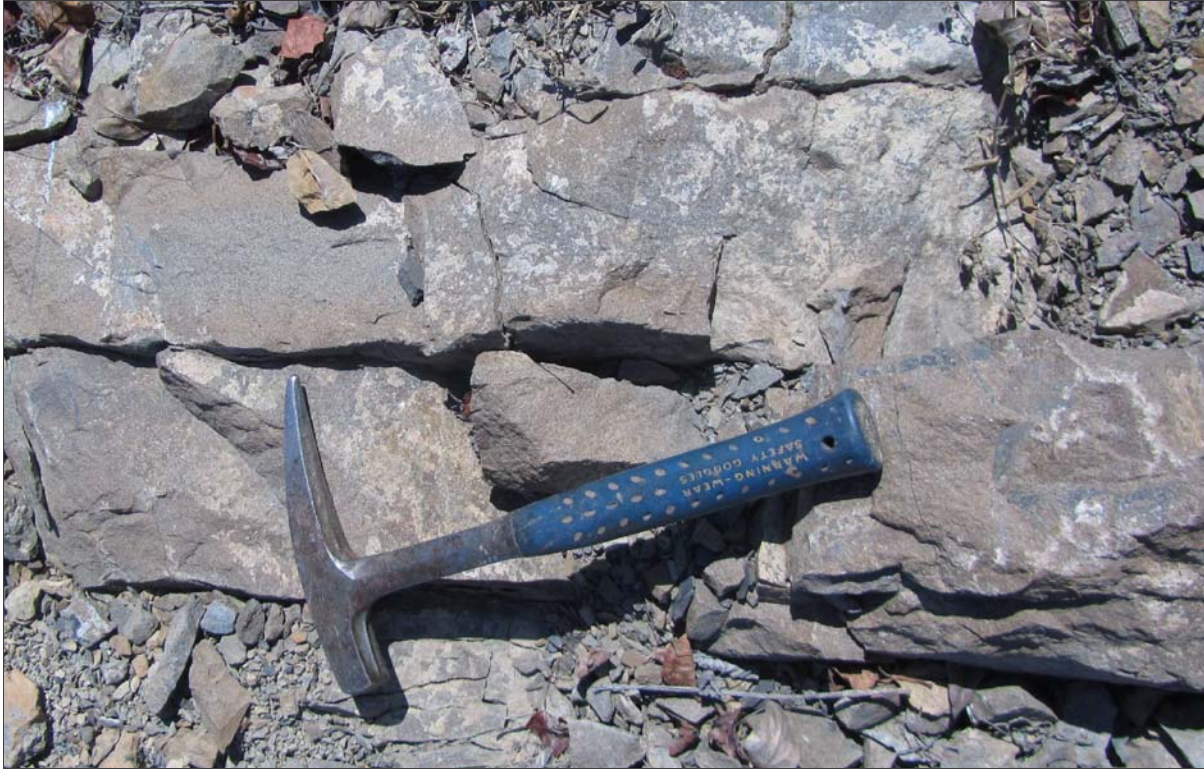
Figure 38 A boulder of coarse grained sandstone-conglomerate from the Cascaden Ridge Formation at Cascaden Ridge, near Mile 57.9 of the Elliott Highway

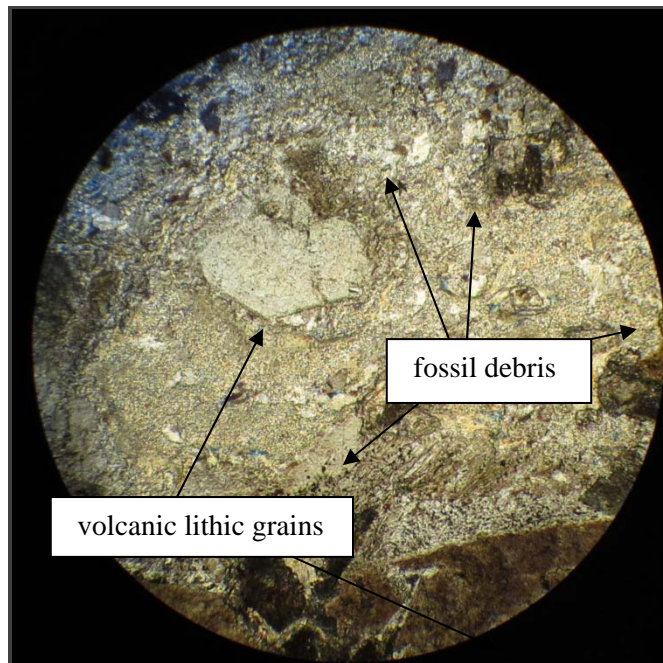
Figure 39 Photomicrograph of tuffaceous sandstone from the Cascaden Formation (Dcb) at station #205373, crossed nicols, 100X; shows large volcanic grains and fossil fragments (shell debris)

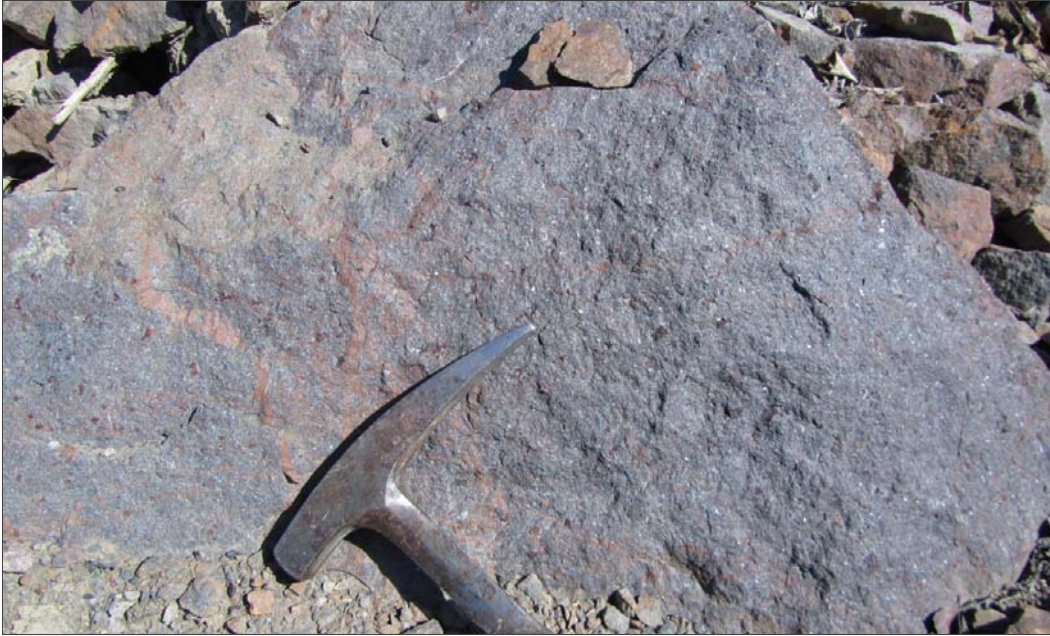
Figure 40 An iron stained diabase sill at station #205442 in the Livengood ophiolite section, illustrating the relative freshness of these exposures in a serpentinite-dominant unit

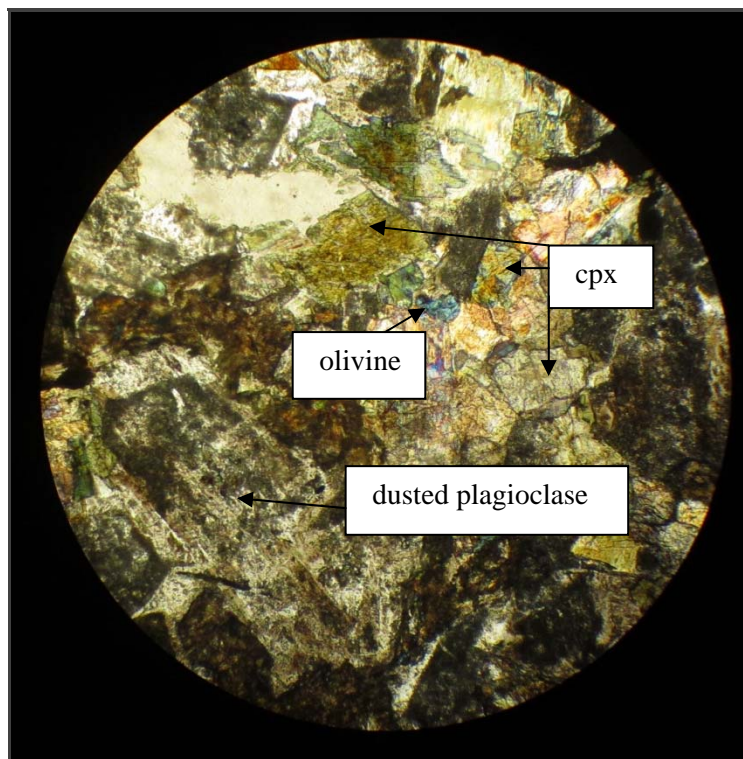
Figure 41 Photomicrograph of diabase/gabbro Livengood ophiolite unit (MzZum) from station #205262, crossed nicols, 100X; shows clinopyroxene grains, dusted calcic plagioclase, and olivine

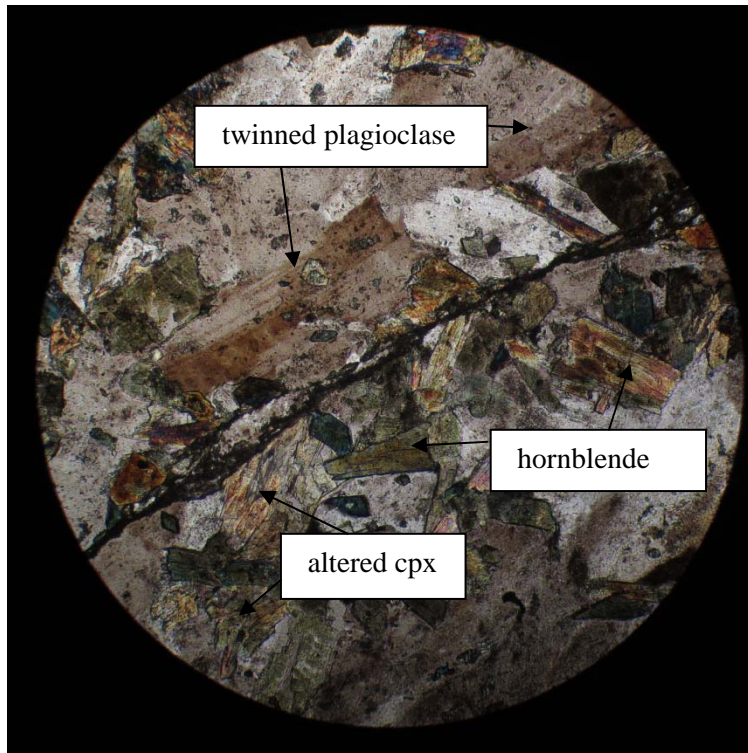
Figure 42 Photomicrograph of diabase/gabbro Livengood ophiolite unit (MzZum) from station #205442, crossed nicols, 100X; shows twinned calcic plagioclase (An=65); primary amphibole and clinopyroxene

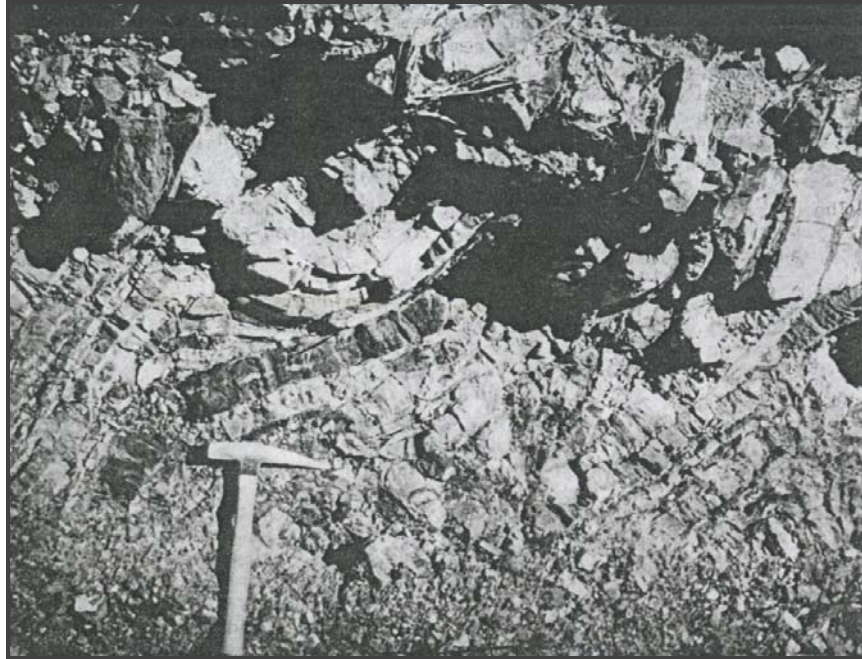
Figure 43 An exposure of Livengood Dome chert near Lost Creek, at Mile 72.7 of the Elliott Highway; from Weber and others (1985); near PRGCI sample station #205259

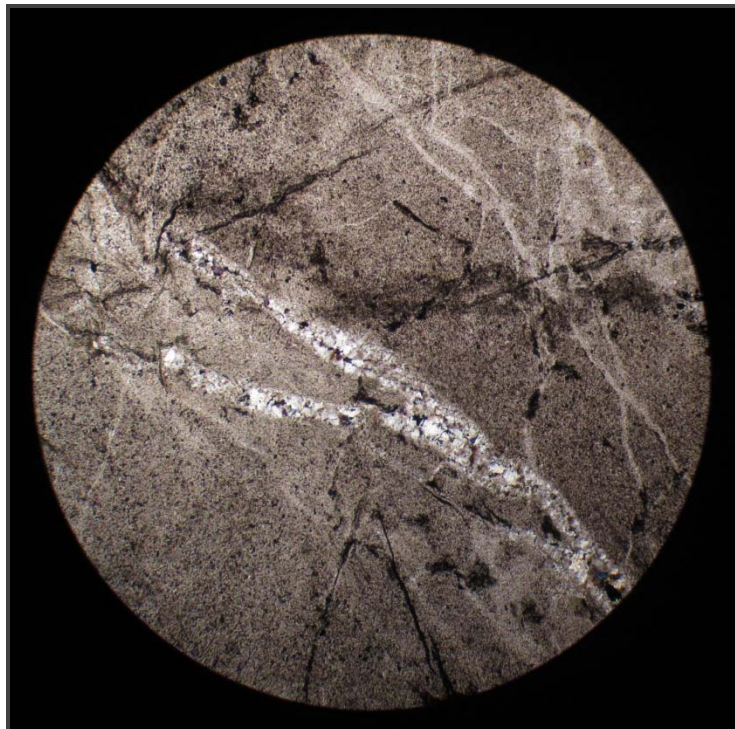
Figure 44 Photomicrograph of the Livengood Dome chert (Oc) from station #205259, crossed nicols, 100X; shows a very fine grained silica matrix that has been cut by remobilized quartz veins and veinlets; note the FeOx veinlets

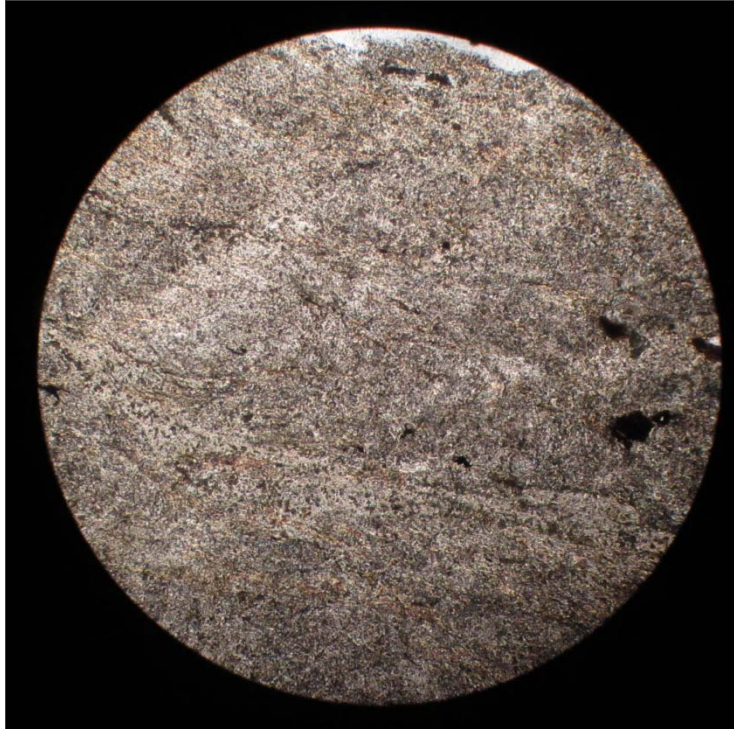
Figure 45 Photomicrograph of Livengood Dome chert (Oc) from station #205260, crossed nicols, 100X; shows the very fine grained silica matrix without remobilized quartz; note the FeOx veinlets and grains throughout the groundmass

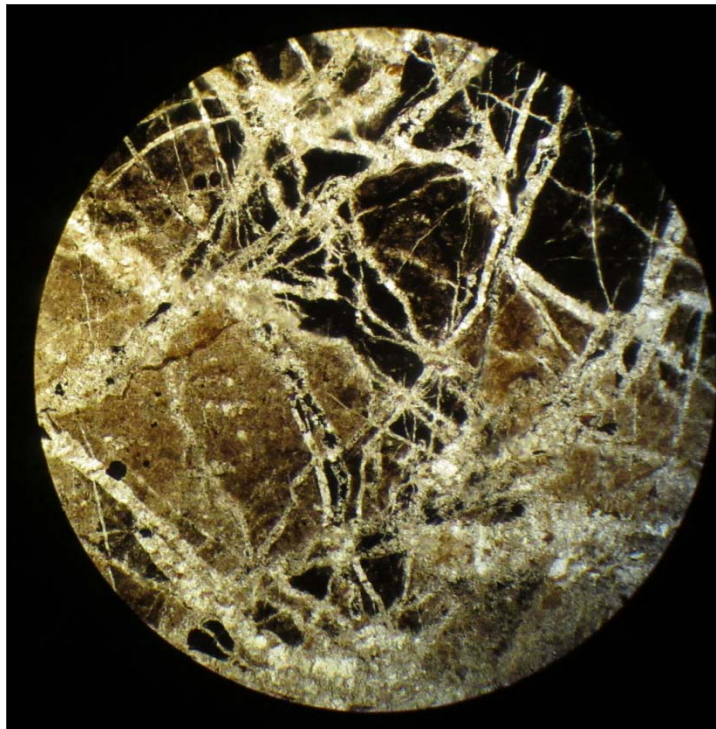
Figure 46 Photomicrograph of Livengood Dome chert (Oc) from station #205261, crossed nicols, 100X; shows the Livengood chert substantially replaced by secondary quartz veinlet zones

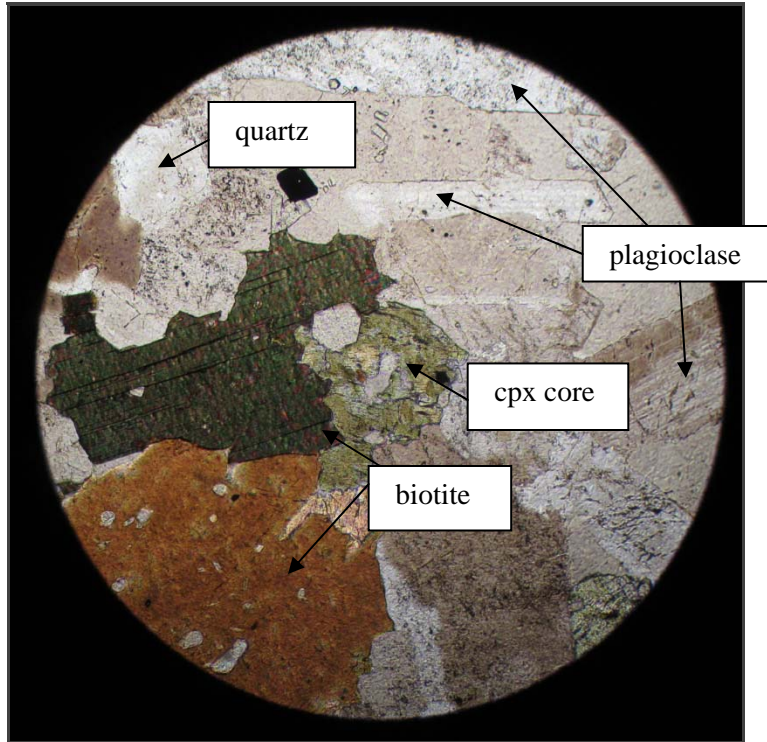
Figure 47 Photomicrograph of Tolovana Hot Springs pluton unit (TKgd) from station #205320, crossed nicols, 100X; shows coarse, fresh, interlocking biotite grains attached to a pyroxene grain in a general groundmass of twinned plagioclase (An25) and quartz; note the freshness of the sample

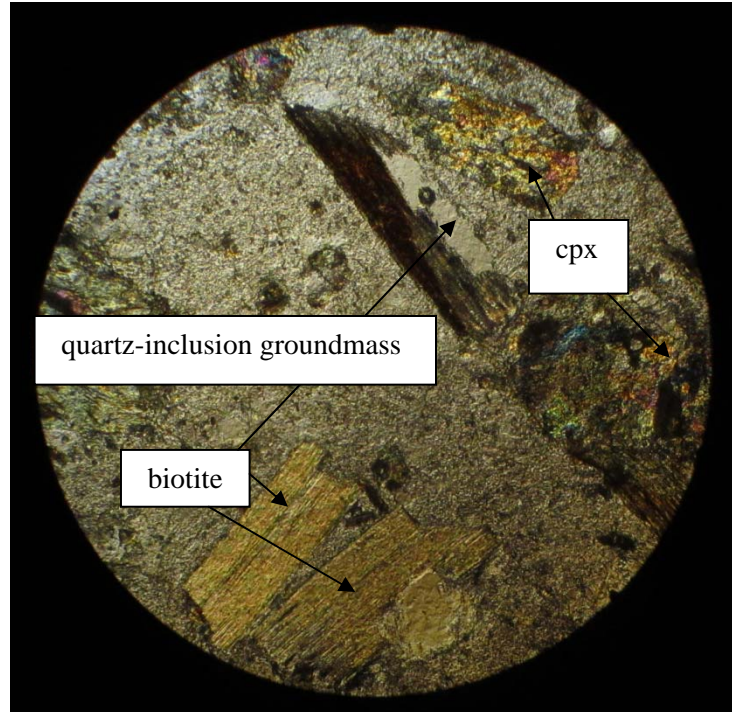
Figure 48 Photomicrograph of the intermediate porphyry near Shorty Creek (unit Tprg) at station #205263, crossed nicols, 100X; shows large biotite grains in inclusion-charged, quartz-rich groundmass, and minor cpx grains

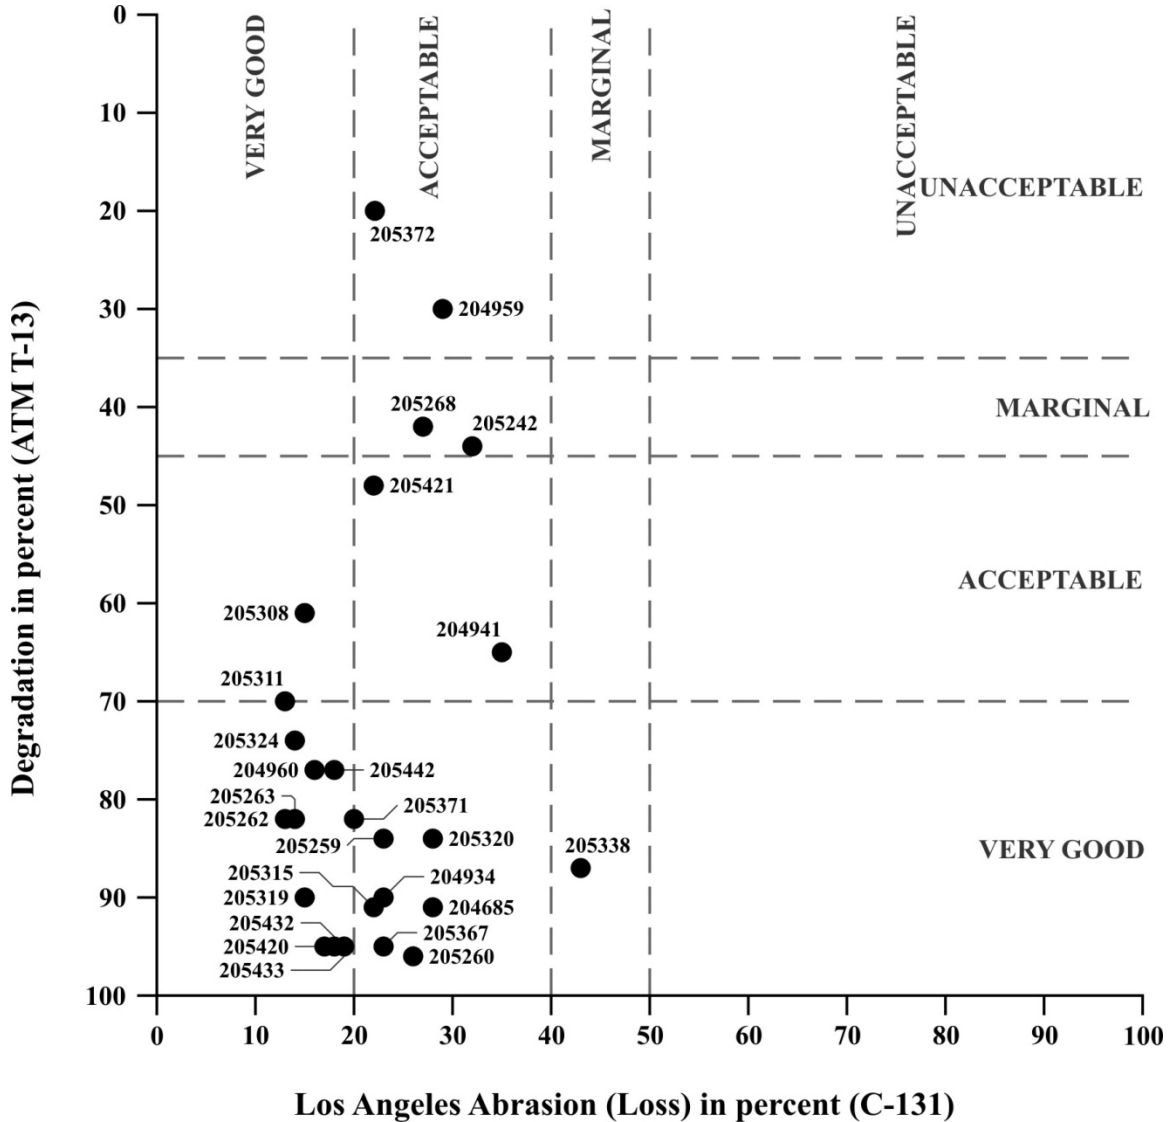
Figure 49 Plot of Los Angeles abrasion (loss) values versus T-13 degradation values, constructed from data from the results of material analyses, Dunbar to Livengood rail corridor project

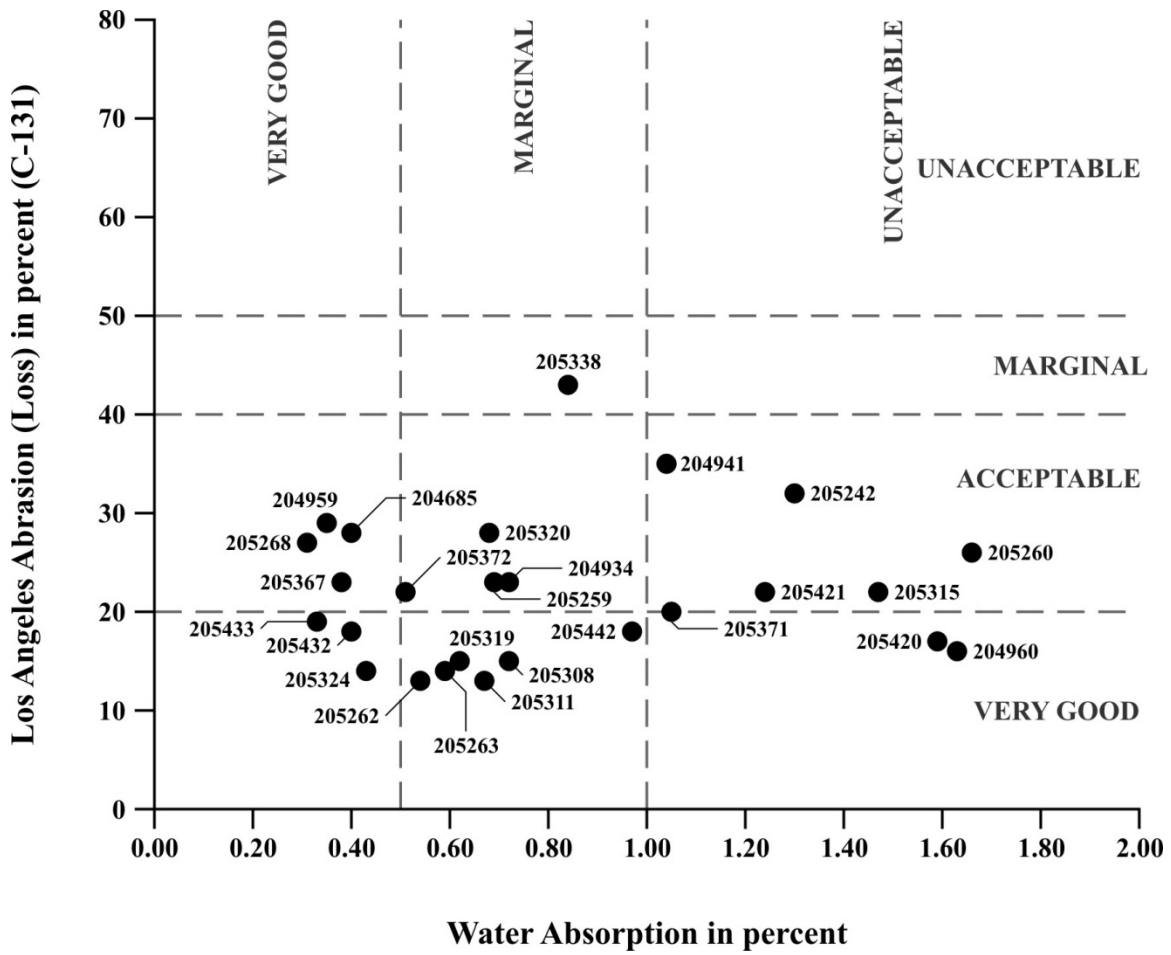
Figure 50 Plot of Los Angeles abrasion (loss) values versus water absorption values, constructed from data from the results of material analyses, Dunbar to Livengood rail corridor project

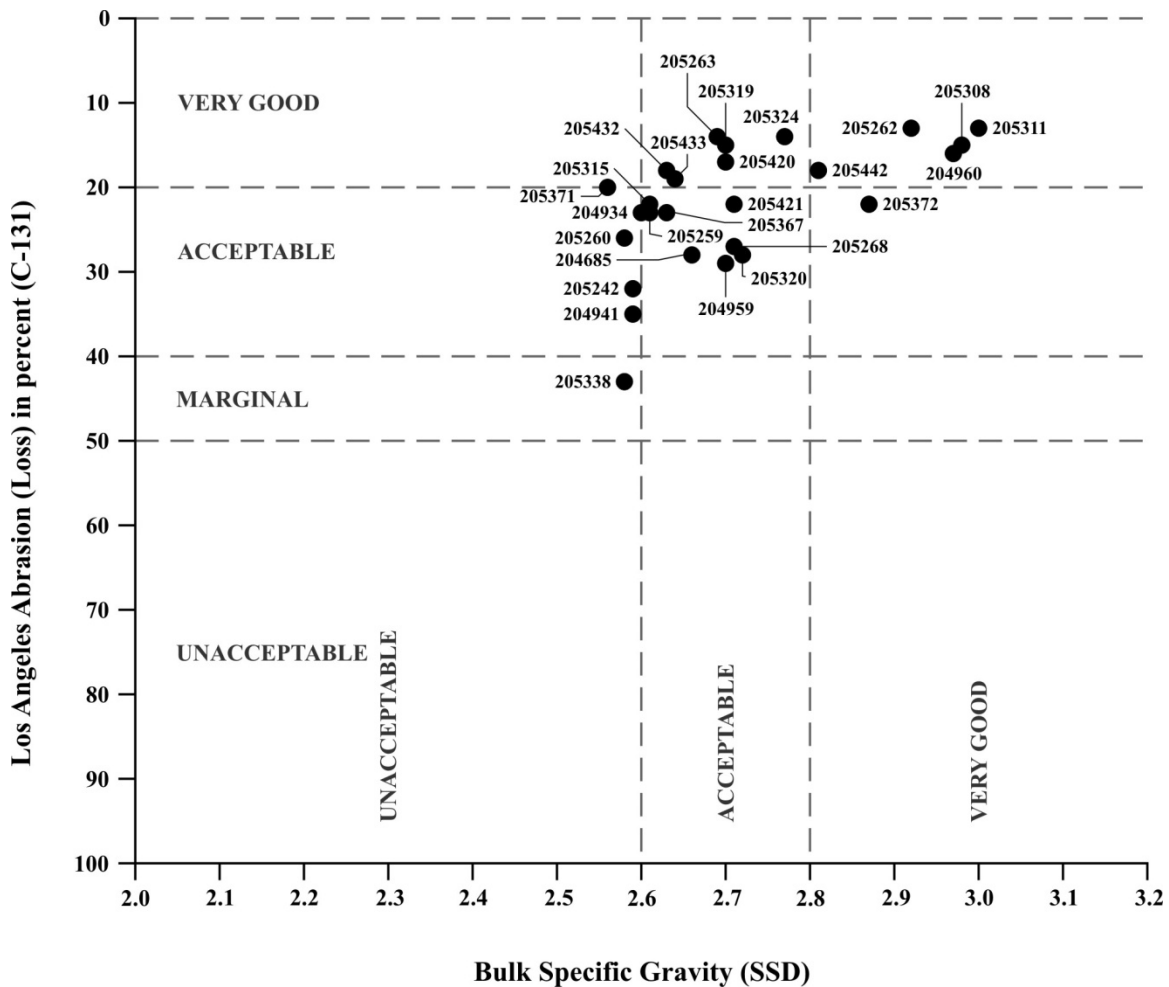
Figure 51 Plot of Los Angeles abrasion (loss) values versus bulk specific gravity (SSD) values, constructed from data from the results of material analyses, Dunbar to Livengood rail corridor project
