Alaska Railroad Corporation Anchorage Diesel Shop, Building 26 Industrial Water Distribution Improvements

PROJECT : **BUILDING 26 DIESEL REPAIR SHOP
INDUSTRIAL WATER DISTRIBUTION**

TITLE: **NEW WATER SERVICE PLAN
FLOOR PLAN & NOTES**

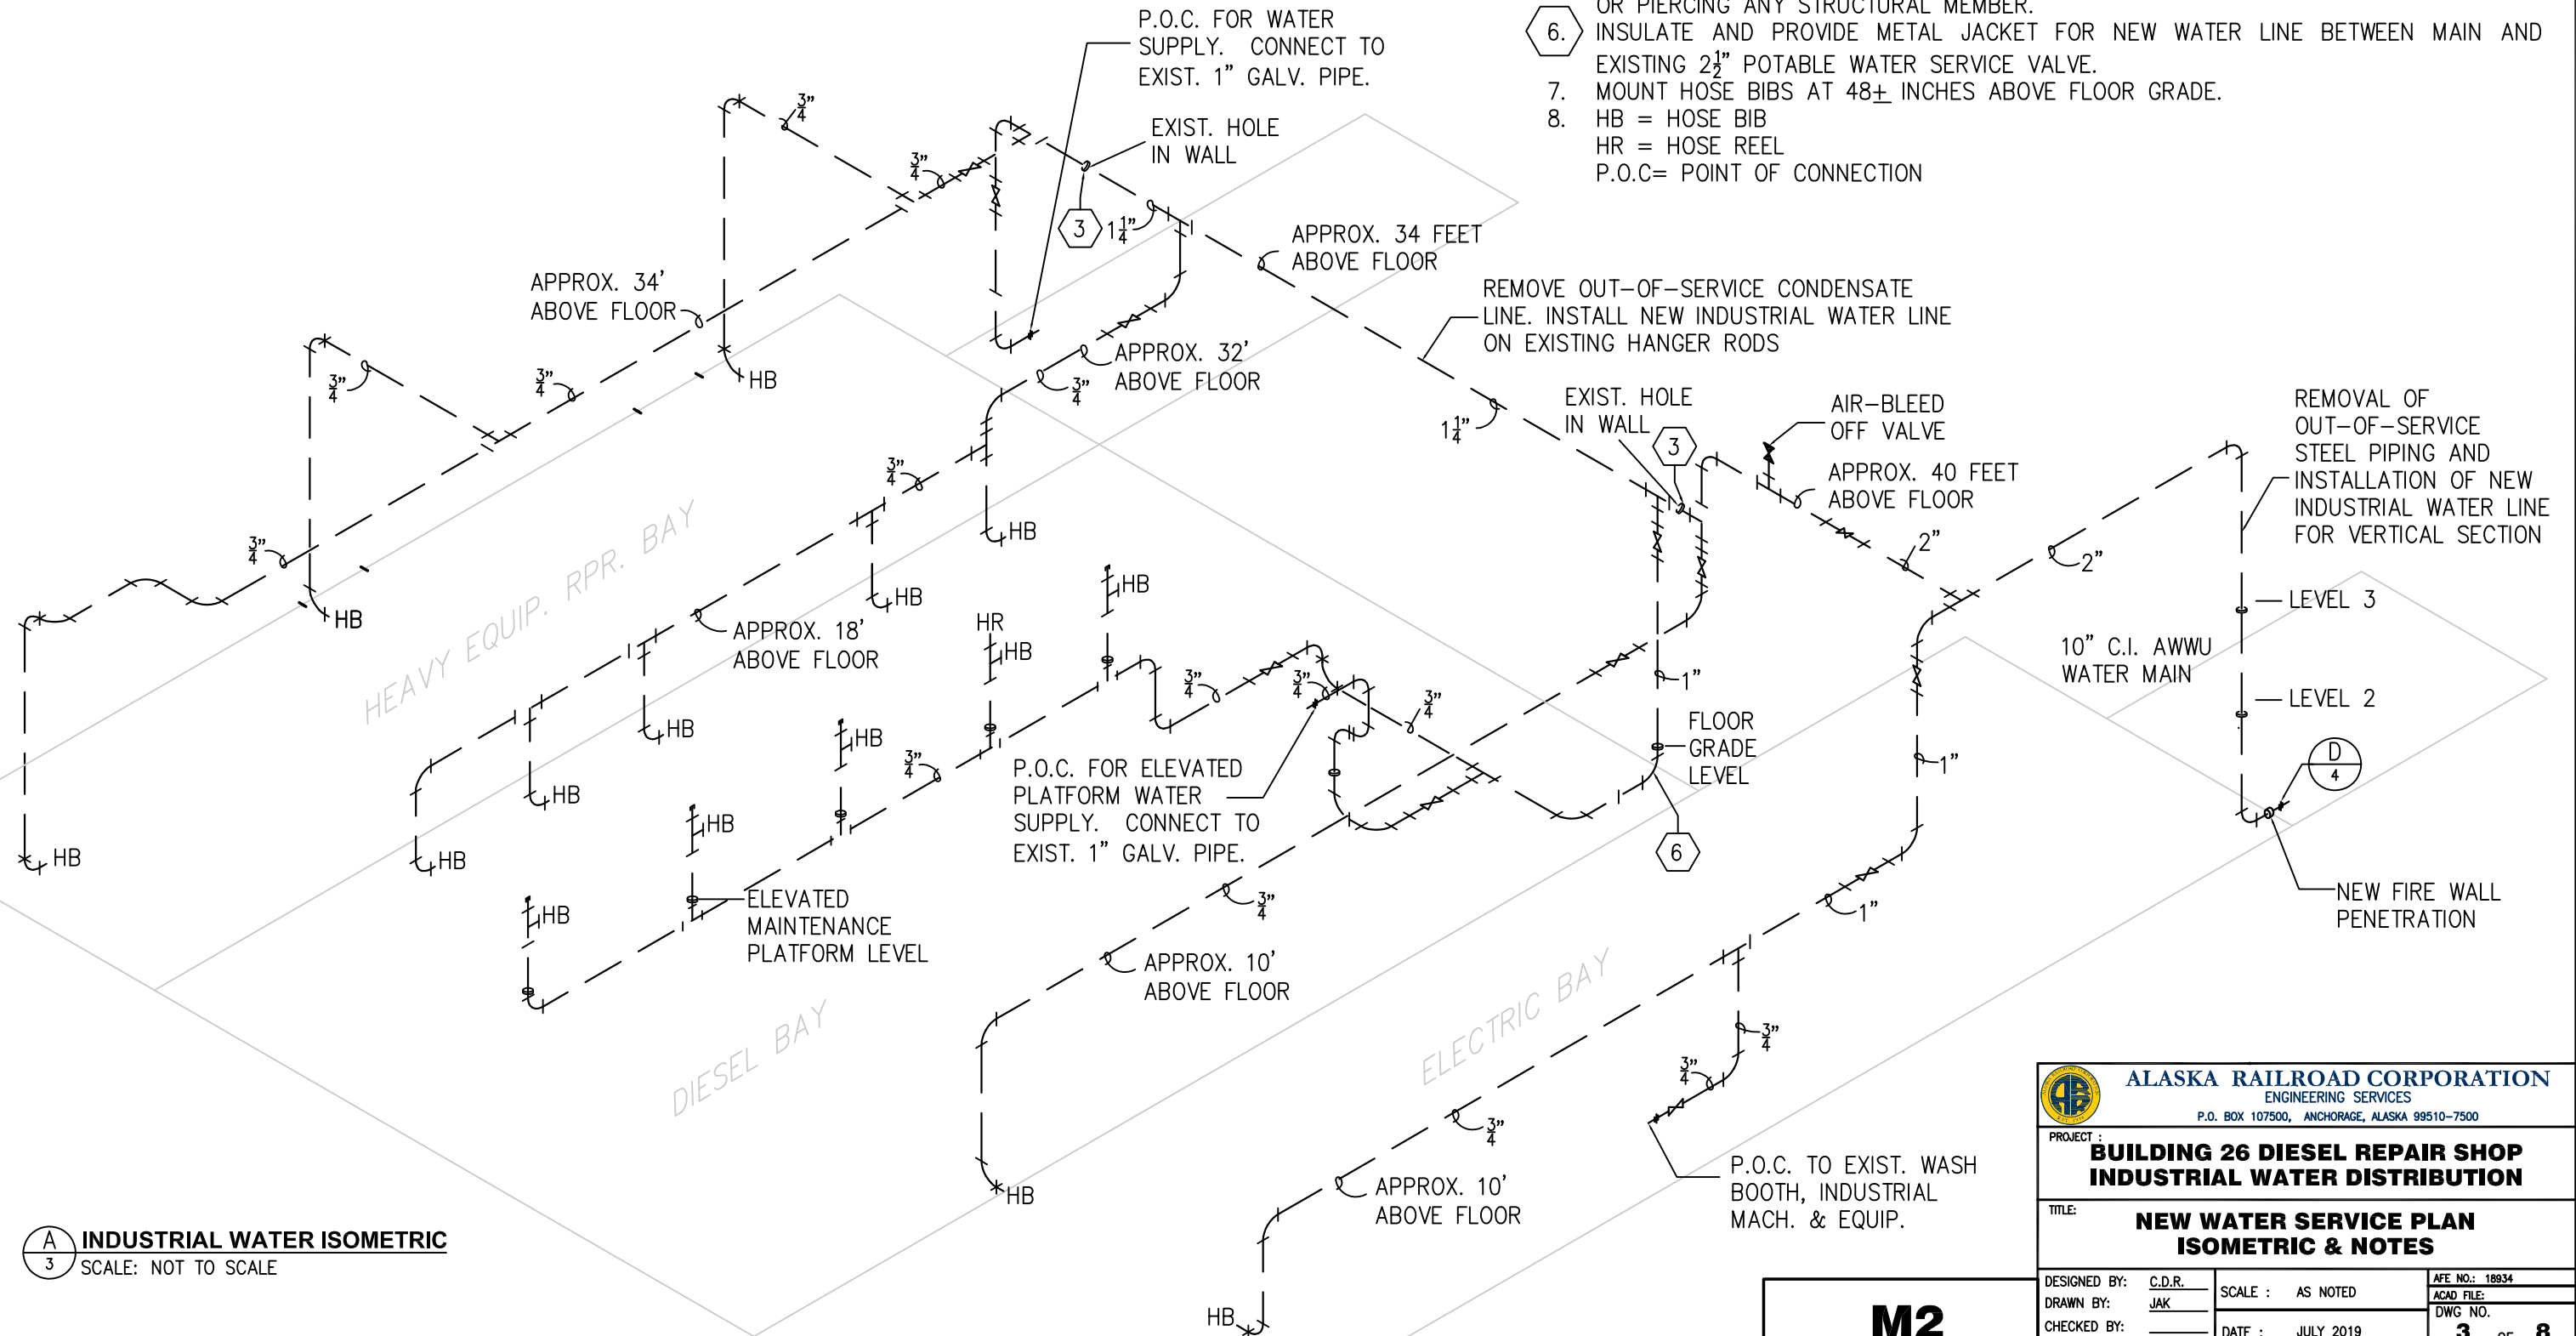
A
3 **INDUSTRIAL WATER ISOMETRIC**
SCALE: NOT TO SCALE

1. BUILDING 26 WATER SERVICE VALVE IS LOCATED IN UTILITY TRENCH. SCHEDULE AND COORDINATE WATER OUTAGES WITH OWNER'S REPRESENTATIVE.
2. CONTRACTOR TO REMOVE AND DISPOSE OF EXISTING WATER PIPING, SUPPORTS, AND VALVES BEING ABANDONED BY THIS PROJECT. SUPPORTS WELDED TO STRUCTURE, OR SUPPORTING OTHER UTILITIES ARE NOT TO BE REMOVED.
3. CAUTION: UNINSULATED STEAM AND CONDENSATE LINES ARE LOCATED IN THE UTILITY TRENCH AND BASEMENT UTILITY ROOM.
4. USE EXISTING PENETRATIONS THROUGH WALLS AND CONCRETE PLATFORMS, EXCEPT WHERE SPECIFIED.
5. OBTAIN WRITTEN PERMISSION OF OWNER'S REPRESENTATIVE BEFORE CUTTING, WELDING, OR PIERCING ANY STRUCTURAL MEMBER.
6. INSULATE AND PROVIDE METAL JACKET FOR NEW WATER LINE BETWEEN MAIN AND EXISTING 2 1/2" POTABLE WATER SERVICE VALVE.
7. MOUNT HOSE BIBS AT 48± INCHES ABOVE FLOOR GRADE.
8. HB = HOSE BIB
HR = HOSE REEL
P.O.C.= POINT OF CONNECTION

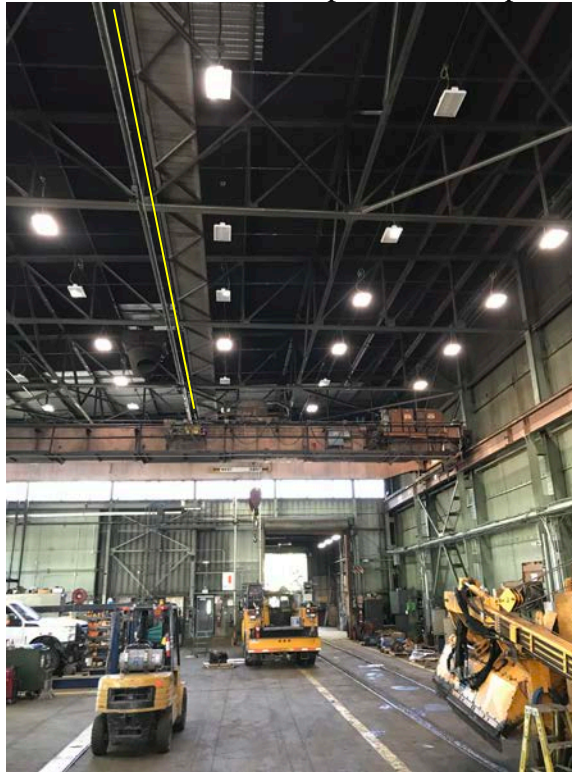
Photo 4: The yellow line shows a portion of the ceiling pipe in the Diesel shop. (April 23, 2019)
